TECHNICAL REPORT
TR-NAVFAC-EXWC-EX-1601
APRIL 2016

**REMOTE COLLABORATIVE 3D PRINTING -
PROCESS INVESTIGATION**

Cody M. Reese, PE

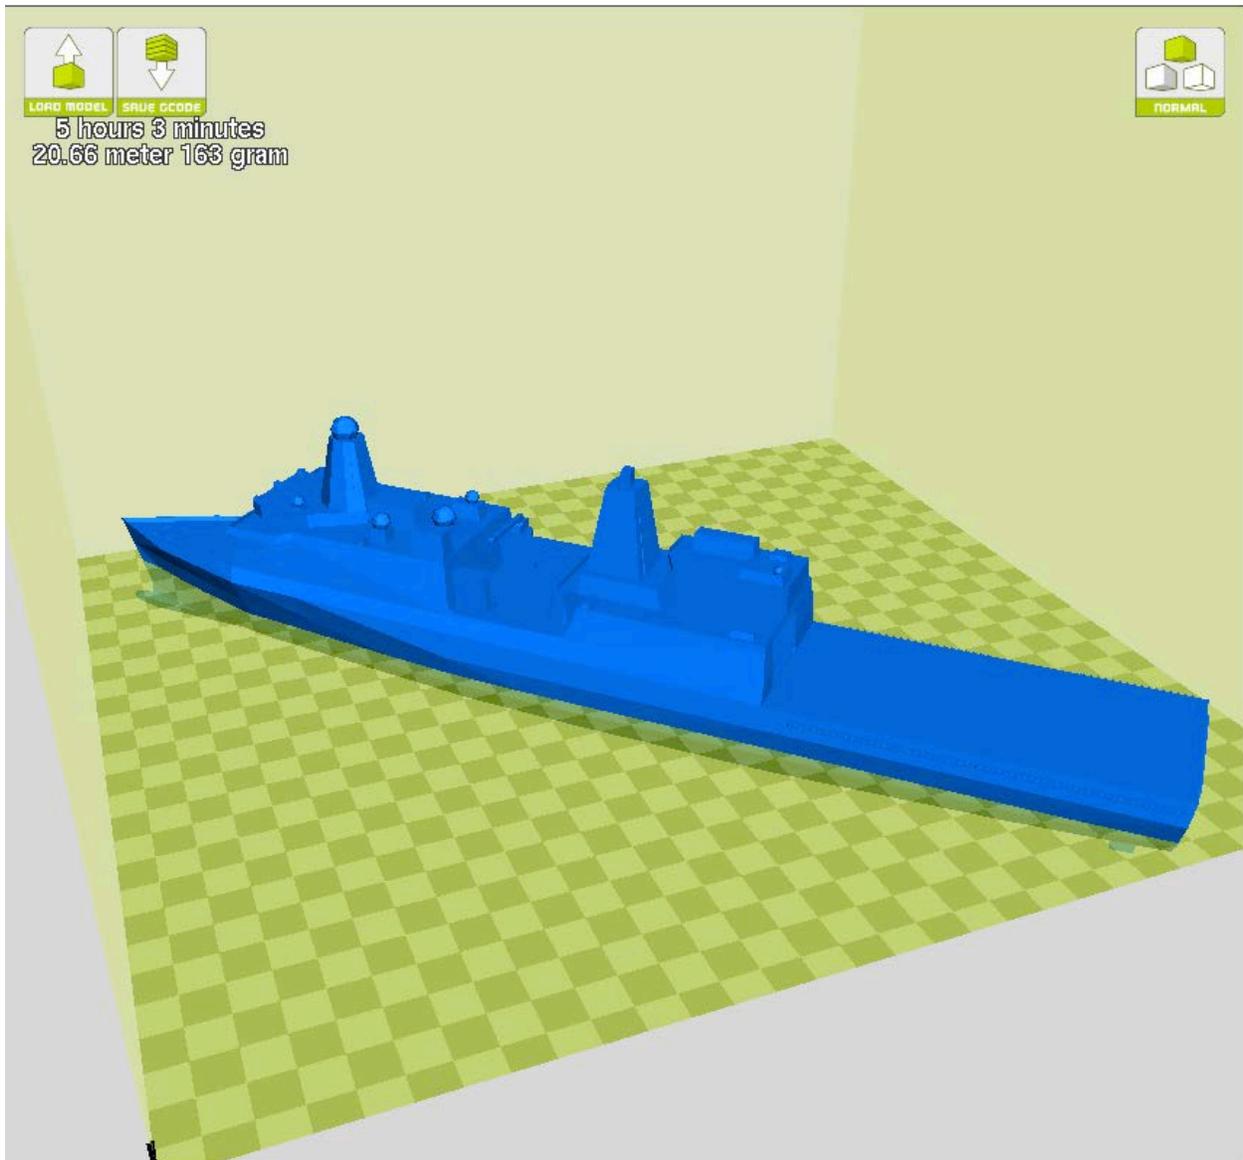
Figure 1: This LPD17 model was sourced from savage.nps.edu, converted from .x3d to .stl using Blender, and loaded into Cura slicing software.

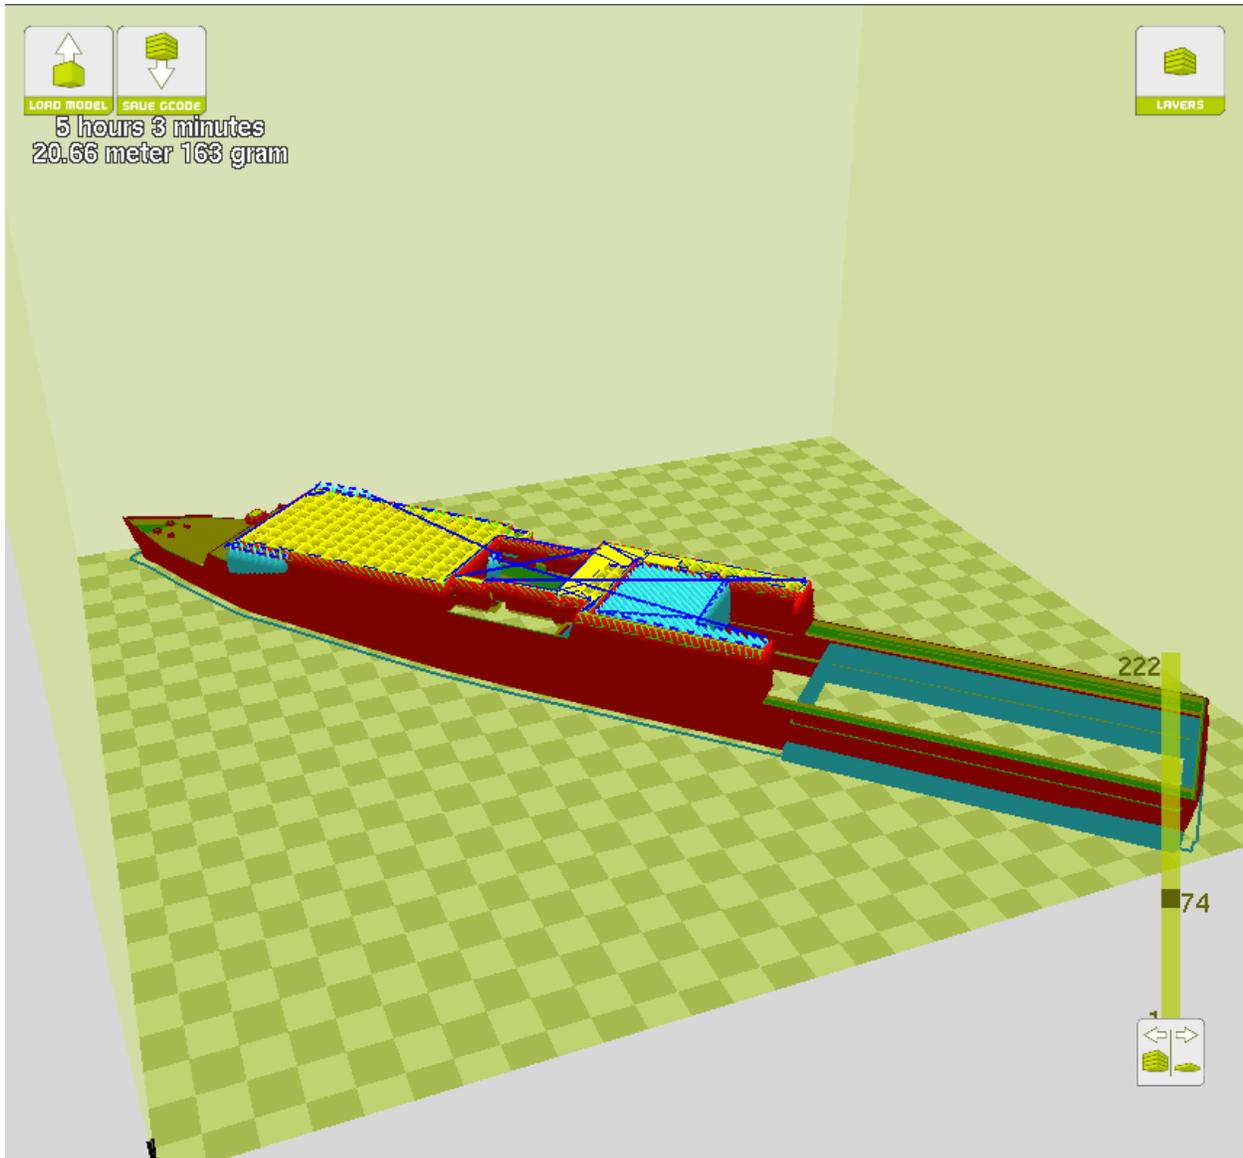
Figure 2: Slicing software such as Cura is able to display a layer-by-layer build preview. Here, red represents shell material, yellow represents infill, light blue represents support, and dark blue represents nozzle-movement.

4. Preview print operation: Once the print parameters have been set, a tool path is generated in the slicing engine, and a layer-by-layer preview of the print operation is presented, as shown in figure 2. This preview is reviewed for any irregularities that may lead to print failure, such as missing layers, strange tool path movements, or unsupported overhangs.

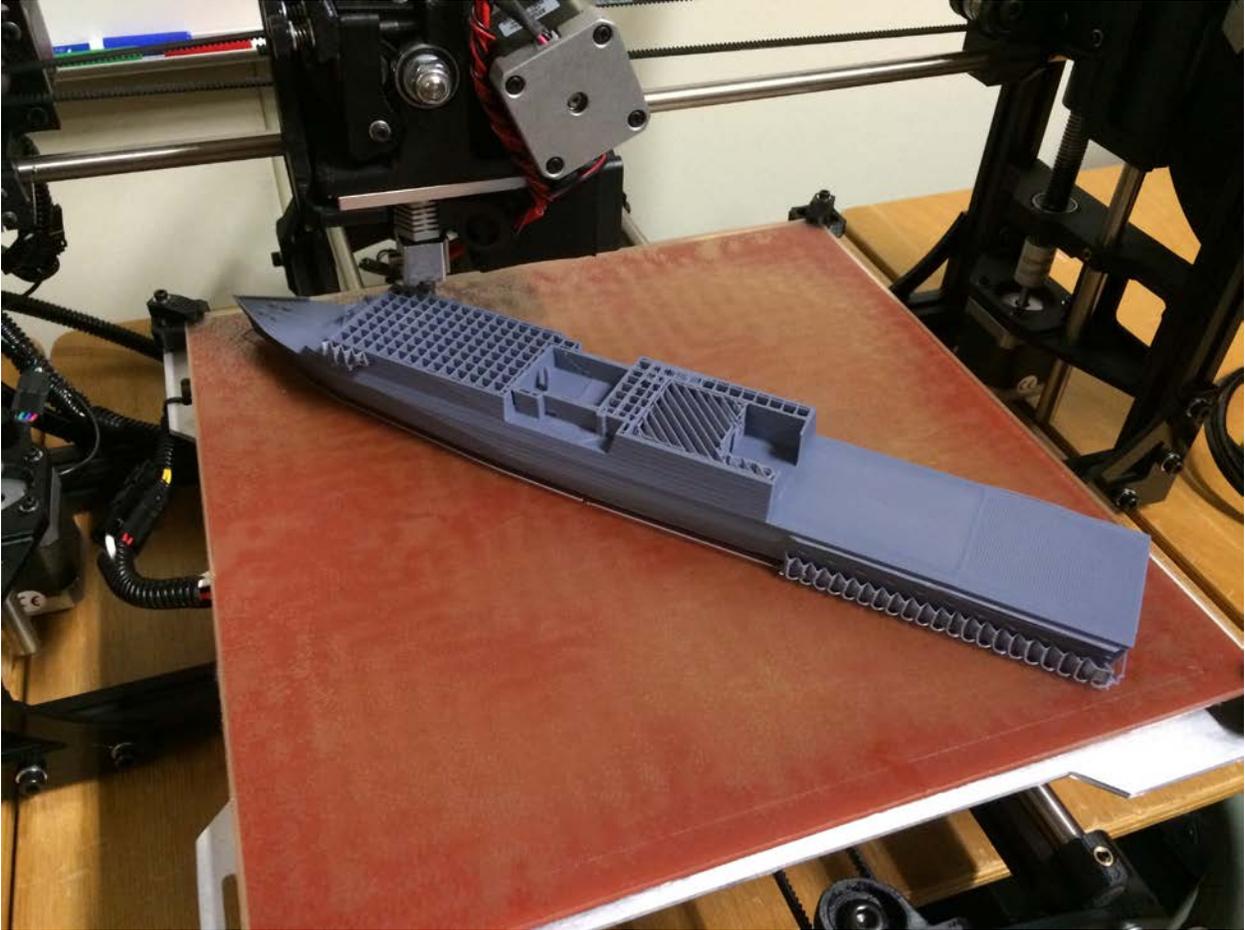
Figure 3: The execution of the print job exactly matches the build preview as displayed in Cura.

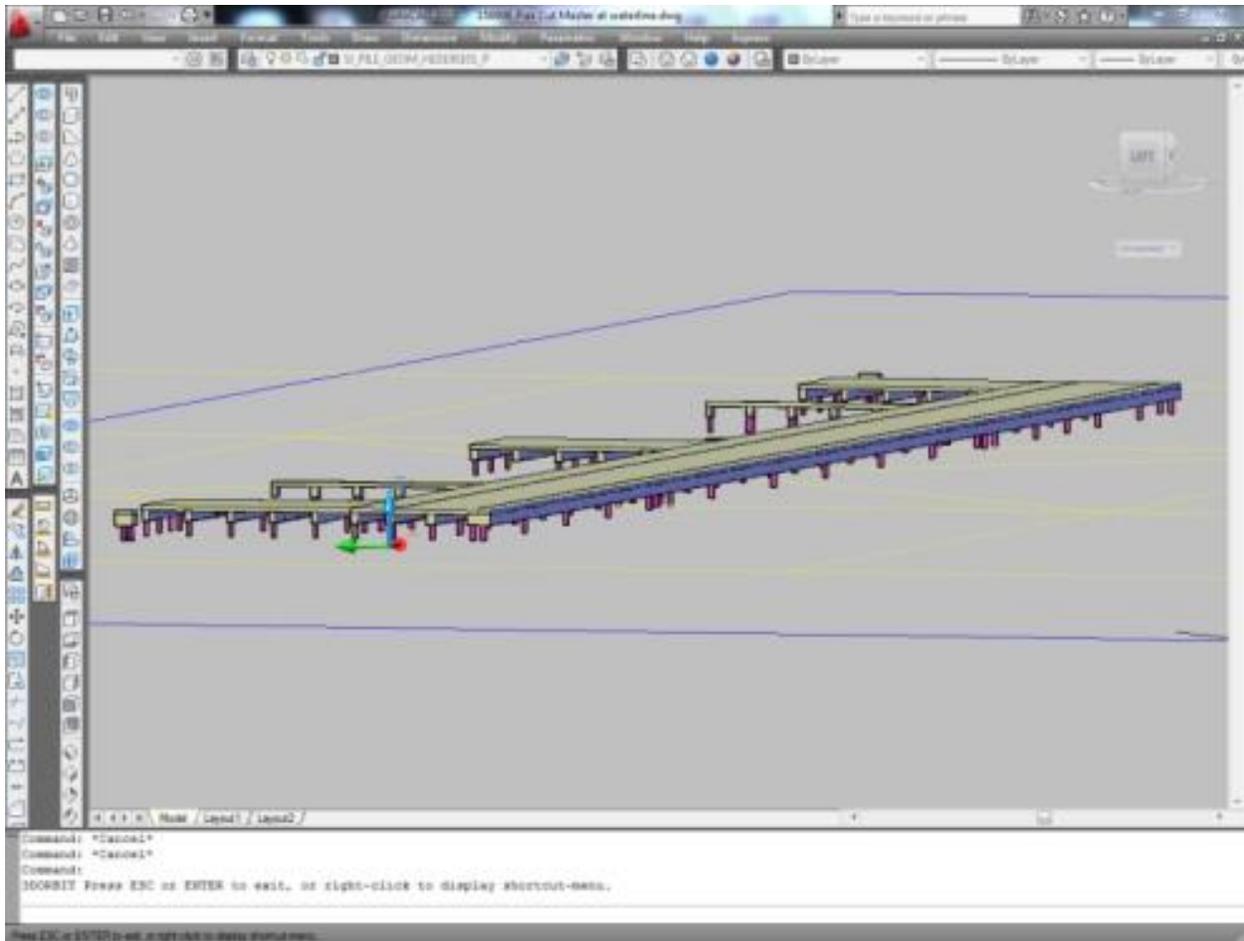
Figure 4: The NOTU pier was prepared for printing by removing fine detail and superfluous components.

Working with AutoCAD 2010, we were able to isolate the sub and the pier into separate files by saving multiple copies of the drawing and deleting the unwanted elements from each. The pier was divided into three sections to enable printing of the facility at a relevant scale, from within the constrained print volume of the 3D printers. Interlocking features were designed into each section to facilitate connection and alignment on reassembly. Deck features were stripped, the pilings were cut at the waterline (as shown in figure 4), and support features (i.e. feet) were added to improve the stability and robustness of the model. After manipulation of the models in AutoCAD, the files were saved as .stl files, burned to a CD, and loaded into Cura (a slicing and g-code engine) on a non-NMCI computer. Cura was utilized to adjust print parameters, preview jobs, and output g-code to drive the printers. To print on the TAZ5, the g-code was transferred to an SD card, which was inserted into the TAZ5 printer, and models were printed directly from the card using the printer control panel. Several print jobs were executed, in various materials, at various scales, and lessons learned from each iteration were documented.

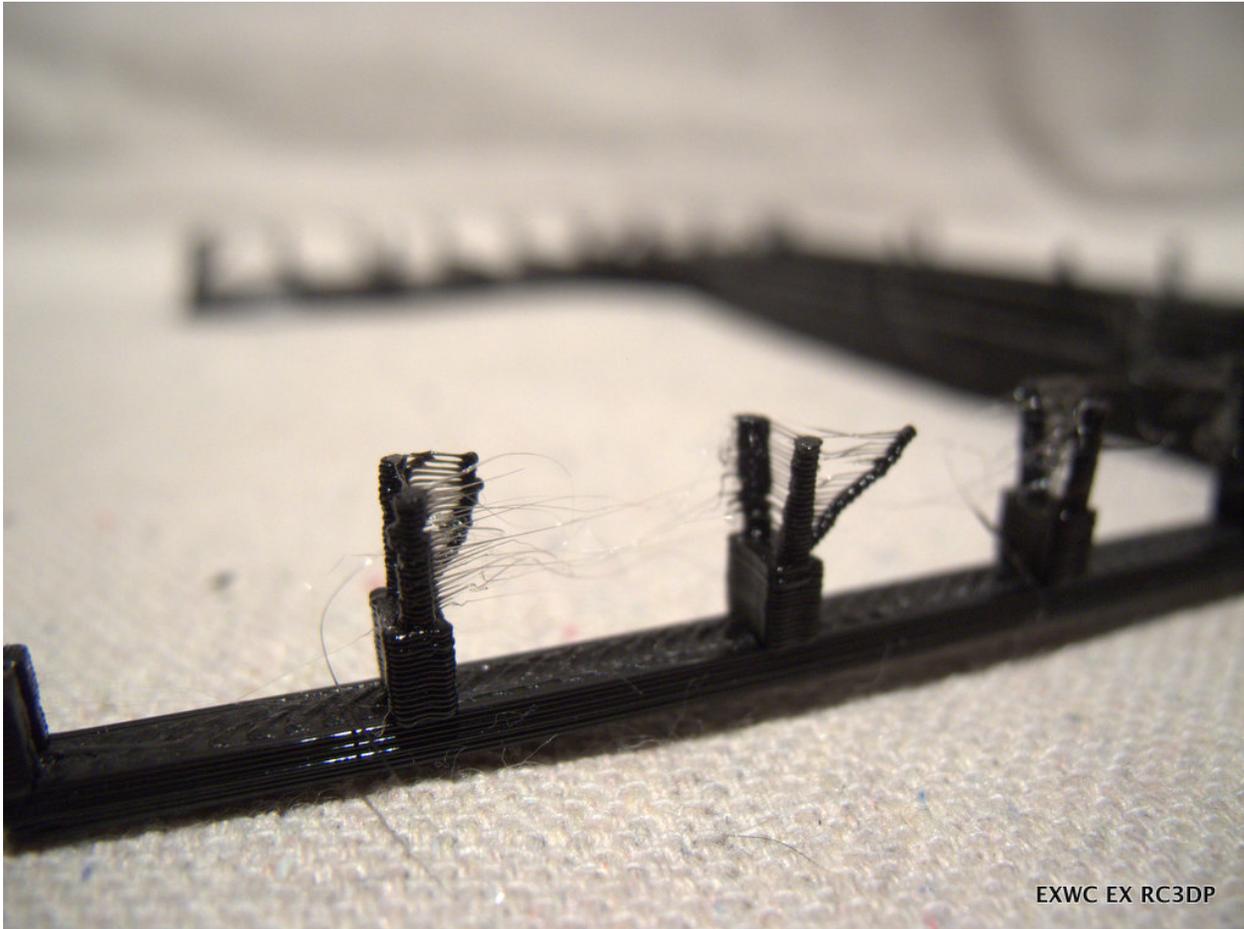
Figure 5: The first print of a NOTU pier section in PLA plastic exhibited extensive flash and filament trails coming from the pilings.

Pier Print 1 (TAZ5-0002): At the desired desktop scale, all surface features on the pier exceed the print resolution of our printers. The pier deck was stripped down to a near-flat surface by cycling through all drawing layers and removing all extraneous components and features. On the underside of the pier, all pilings were cut at the water-line, and most pilings were removed to increase print speed. For all removed pilings, a socket-like hole was left in place of the piling such that small dowels could be inserted to represent pilings if necessary. This print was executed on the TAZ5 printer in Polylactic Acid (PLA). On this first attempt, a small curb was left around the perimeter of the deck. This geometry resulted in the need for a support layer to be printed under the majority of the deck, which led to difficult post processing and a poor resultant surface finish as shown in figures 7 and 8. The bottom of the part required extensive deburring due to tiny fibers of material left during nozzle transition over an unsupported surface (also known as manufacturing flash, shown in figure 5). This was most apparent on the pilings. Additionally, the printer was unable to resolve the edges of the sockets left in the positions from which we had removed pilings as shown in figure 6. Though a Fused Deposition Model printer may have high accuracy in the XY plane, the resolution of some features (e.g. narrow edges) is determined by the extrusion diameter. In this material, and at this scale, the pilings are extremely fragile, and easily broken off in spite of careful handling.

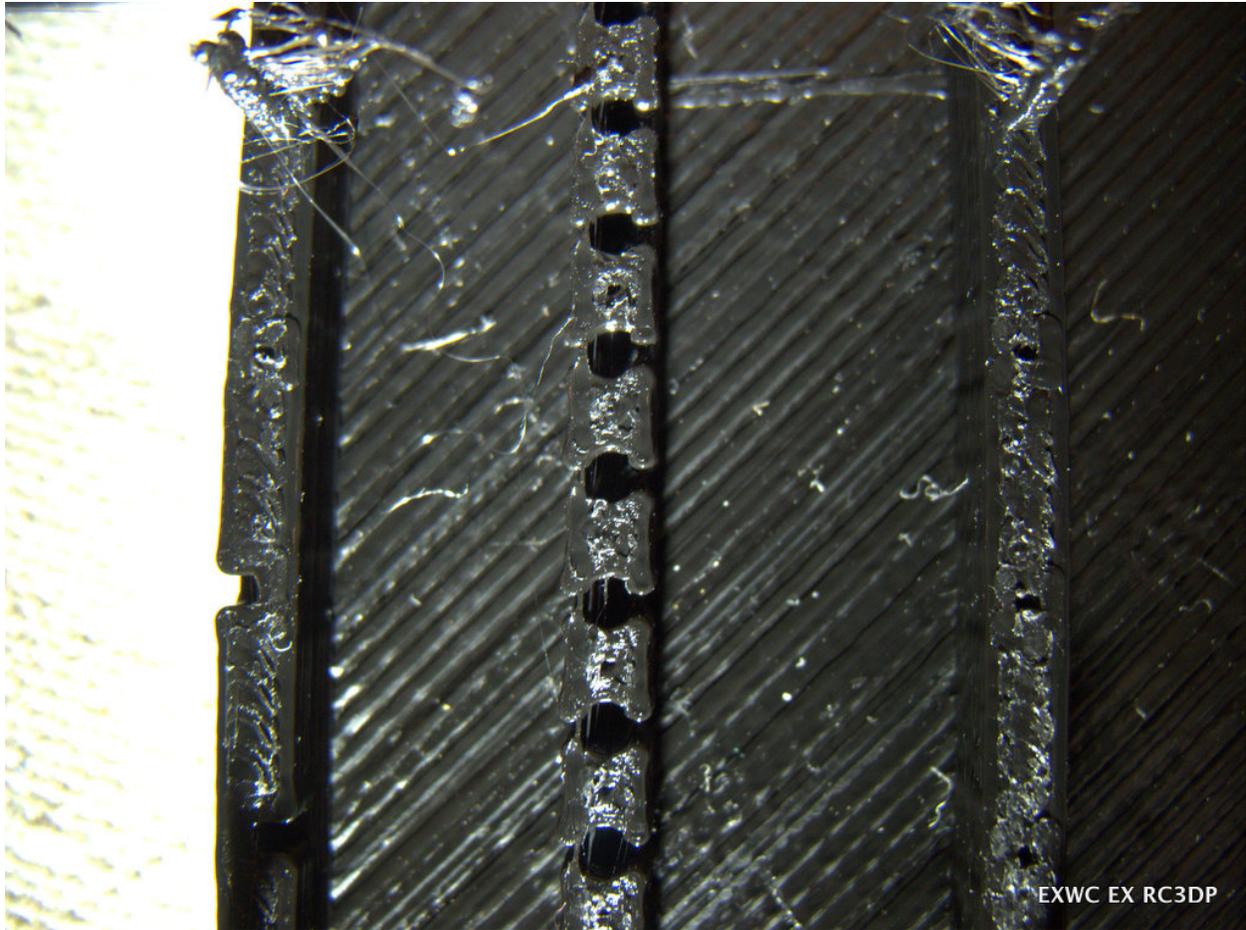
Figure 6: This underside close-up of the first pier print illustrates the inability of an FDM printer to resolve features smaller than the diameter of the extruded filament

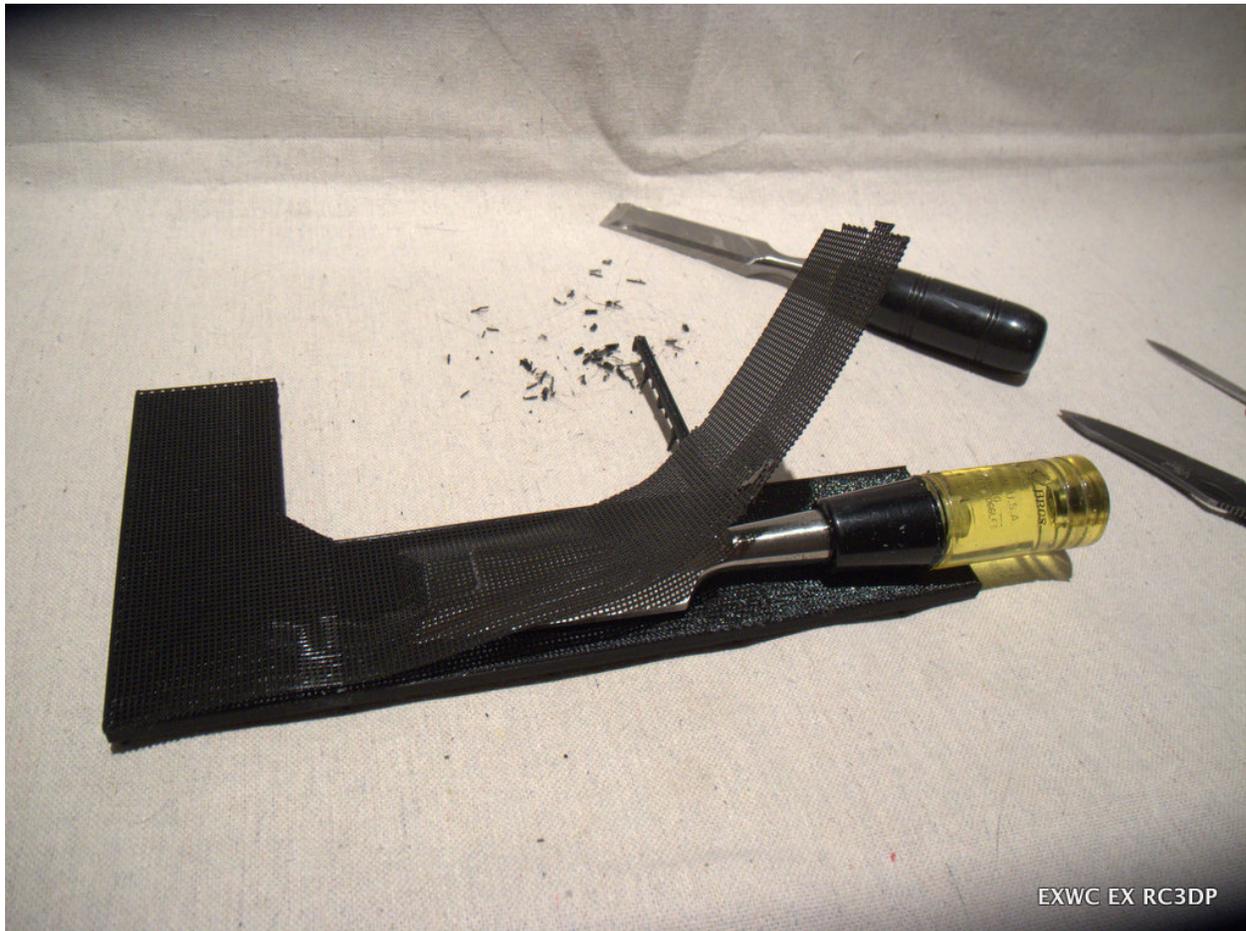
Figure 7: The first printed pier section required extensive deburring due to the support layer printed beneath the entire part.

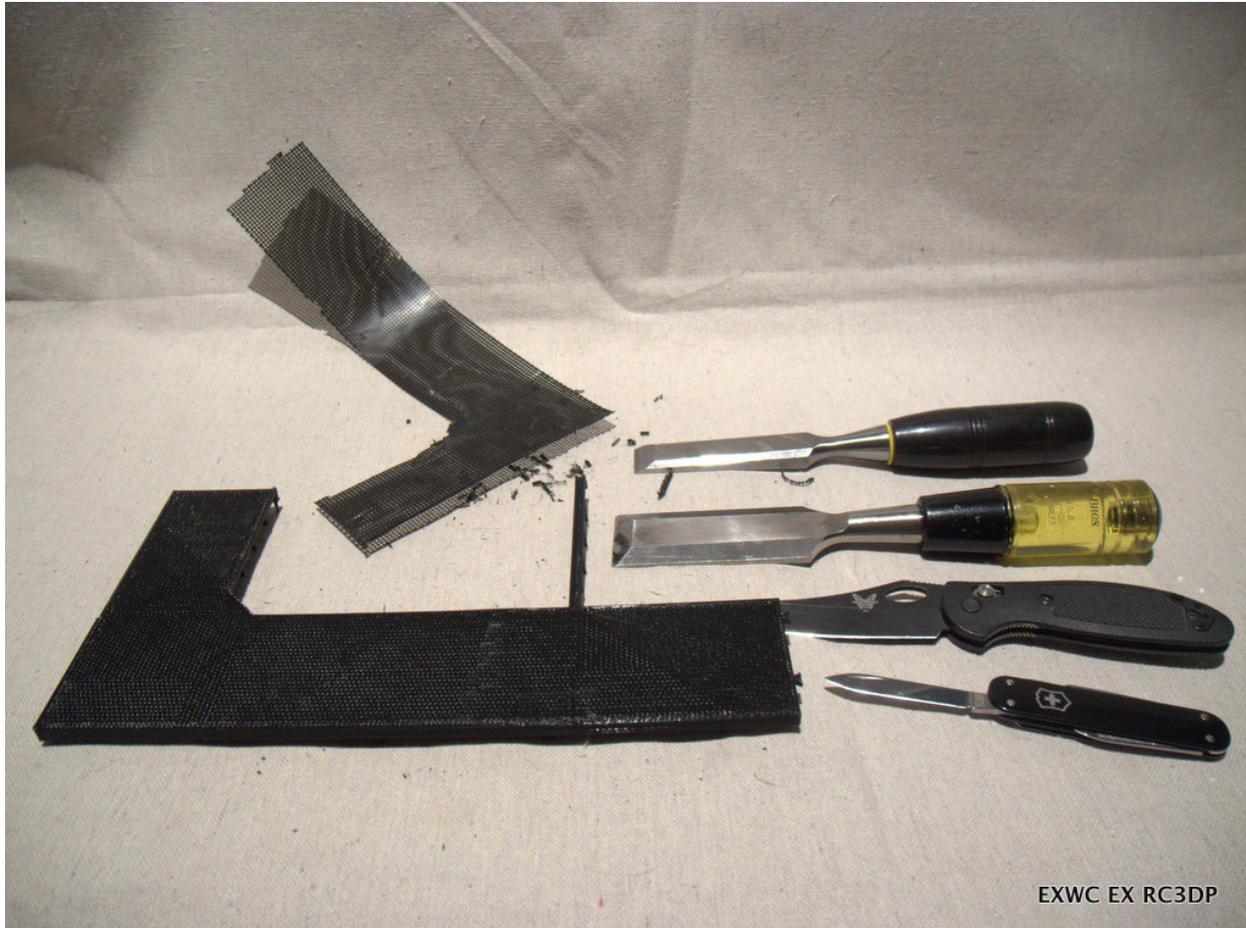
Figure 8: Various tools were used to facilitate the deburring operation, and the rough surface finish of the pier deck can be seen where the support layer was removed.

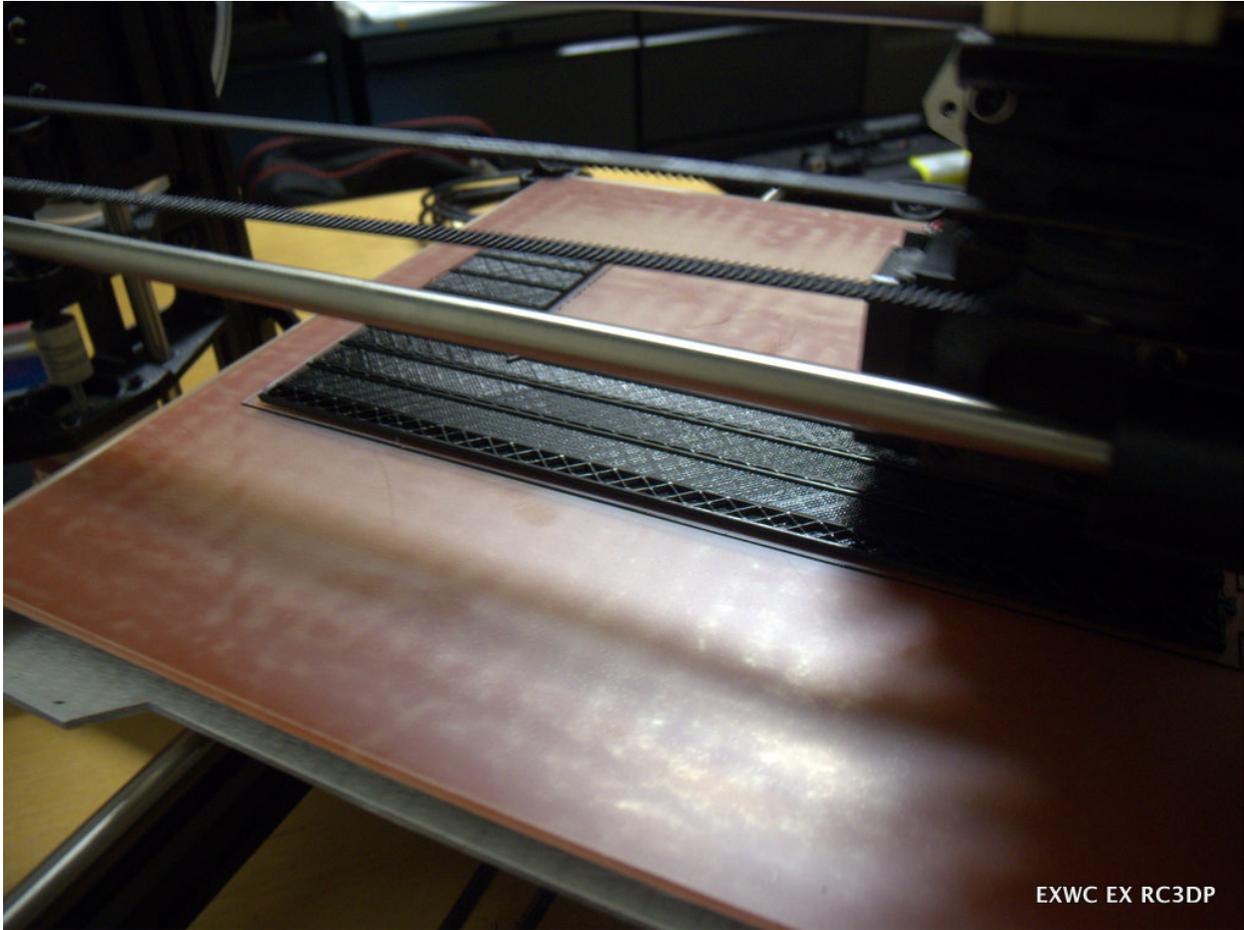
Figure 9: The second print of the NOTU pier with revised parameters shows the thinness of the top layer covering crosshatched infill material.

Pier Print 2 (TAZ5-0003): After the initial attempt, all surface features were eliminated to provide a perfectly flat base layer, all piling sockets were eliminated, and large triangular support features were added to the bottom of the pier to protect the pilings and enhance stability. The flat build surface and elimination of the piling sockets significantly reduced the build time and improved quality. The print parameters were also adjusted to reduce the shell thickness of the part. The single layer of the shell thickness can be observed in figure 9. The resultant print still required extensive deburring of the flash leftover on the pilings.

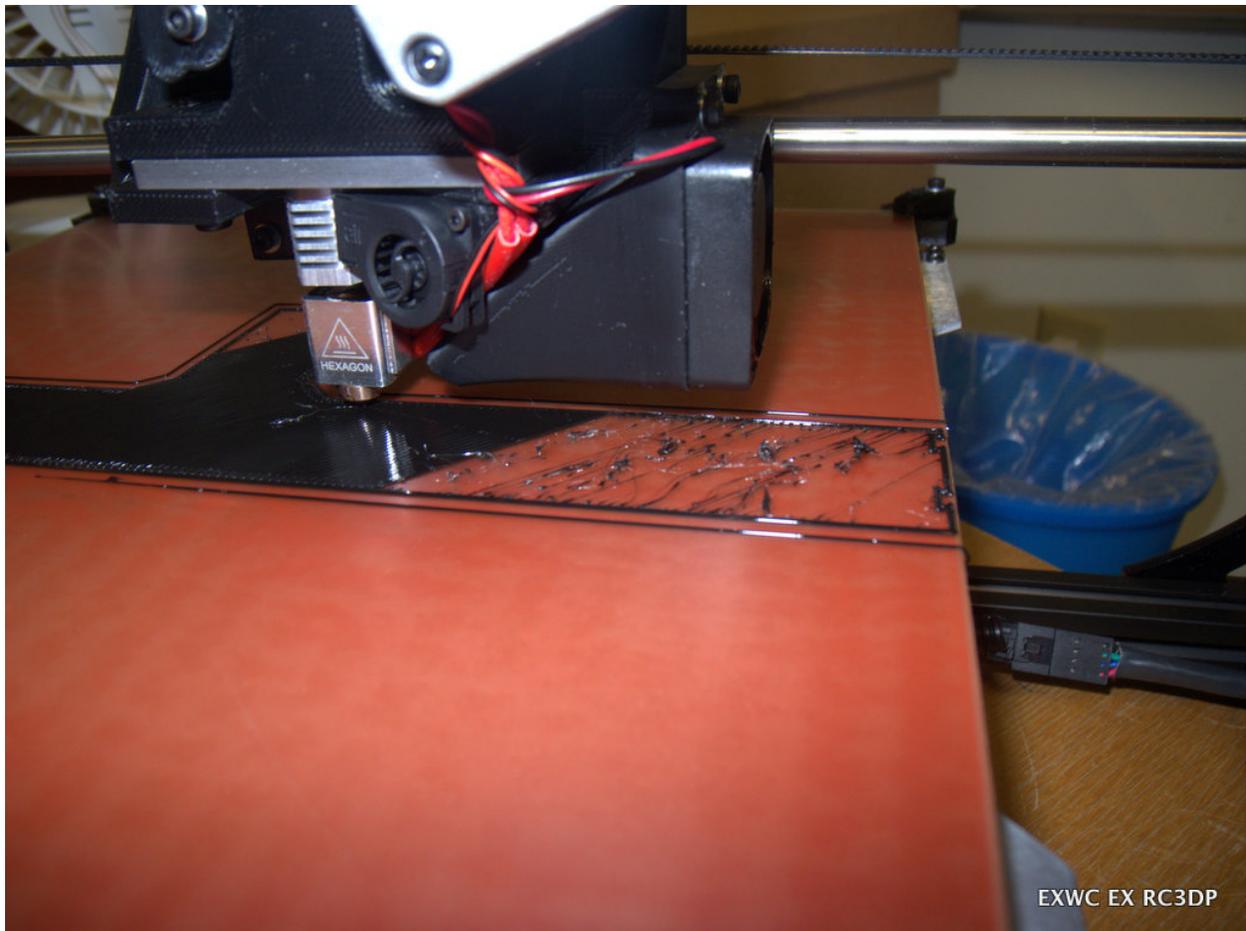
Figure 10: This print failed due to a broken filament feed into the print head.

Pier Print 3 (TAZ5-0004): After the first two attempts, it was realized that the first two pier sections had been printed too large (0.75x scale from the .stl file) to accommodate the longest remaining section (the center section of the pier) within the build volume. The center section of the pier was loaded and scaled to the maximum X-dimension of the build volume (0.51x scale). Due to the smaller scale of the print, the print was generated as a solid body (no fractional infill). Several minutes into the first print layer, the incoming PLA-feed to the print head snapped, resulting in print failure as shown in figure 10.

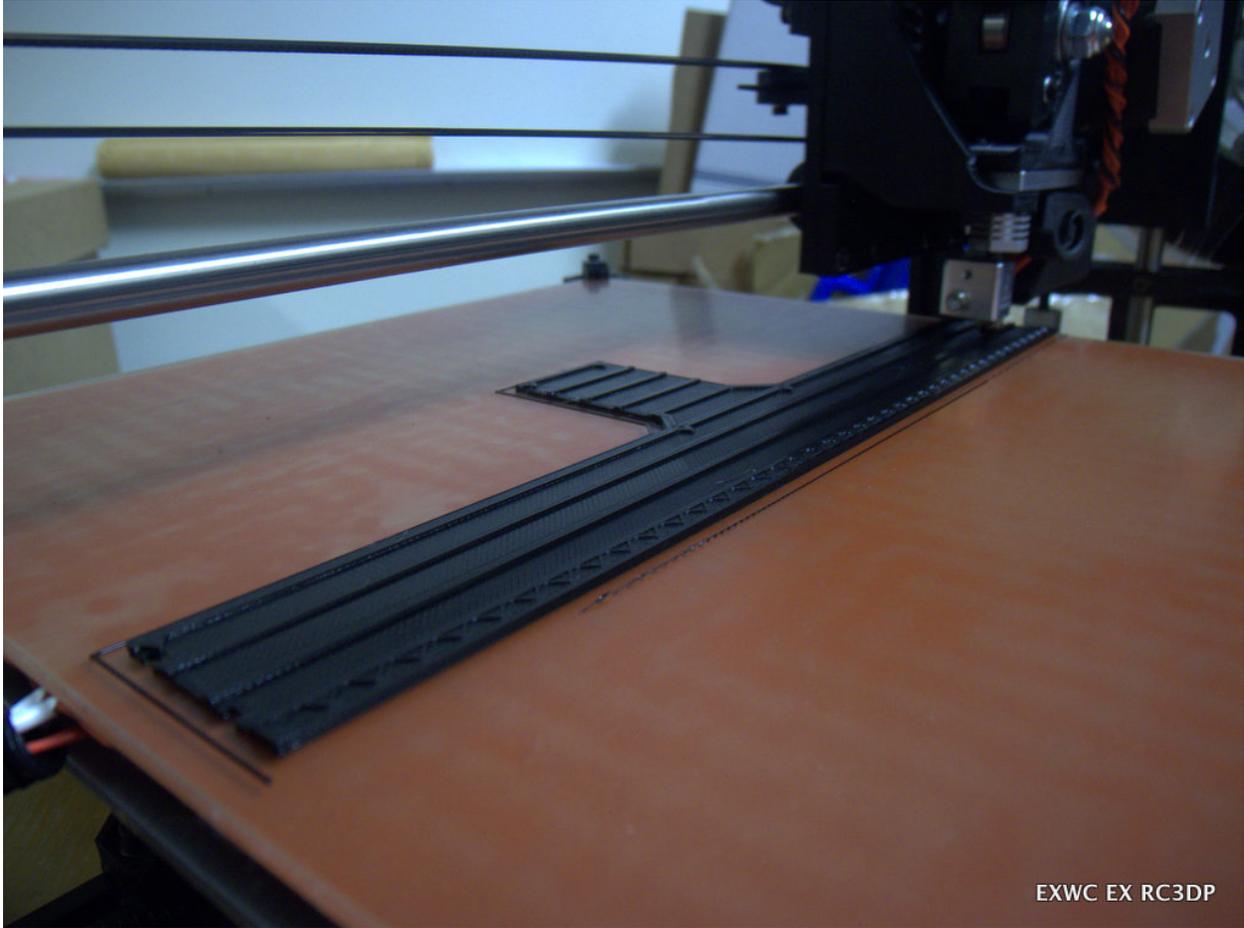
Figure 11: The NOTU pier center section was printed at the maximum available print area of the machine.

Pier Print 4 (TAZ5-0005): The PLS feedstock was reloaded, and the print job of the center section was successfully executed as shown in figure 11. As with the earlier PLA models, the part required extensive deburring of flash from the pilings.

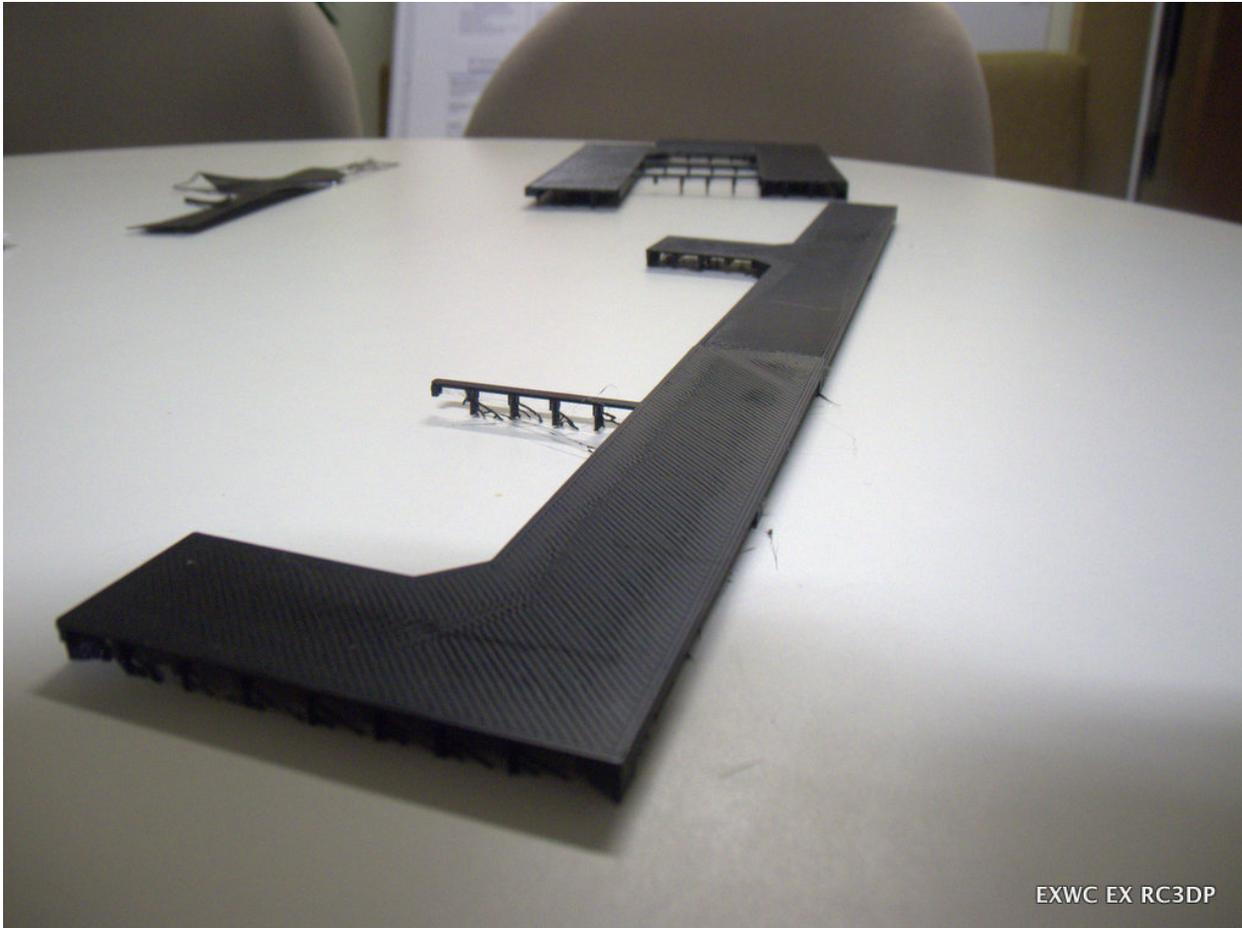
Figure 12: The pier sections were able to be joined together after deburring and interlocking connector finishing operations.

Pier Print 5 (TAZ5-0006): The first pier end section was successfully printed at the 0.51x scale to match the center section. Extensive deburring was required, and the pieces were able to be joined together as shown in figure 12.

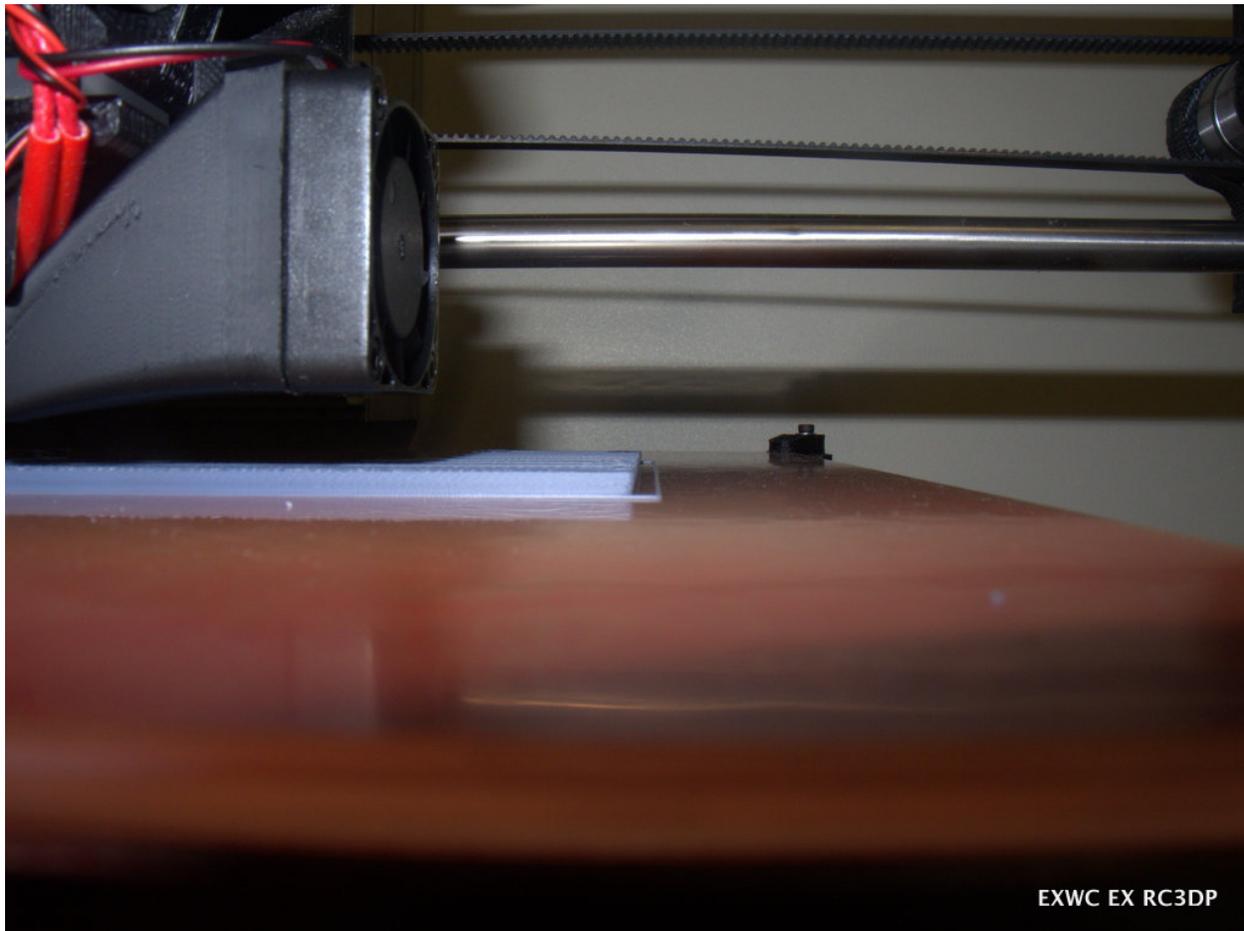
Figure 13: The pier section printed in HIPS showed geometric distortion on what should have been a vertical surface.

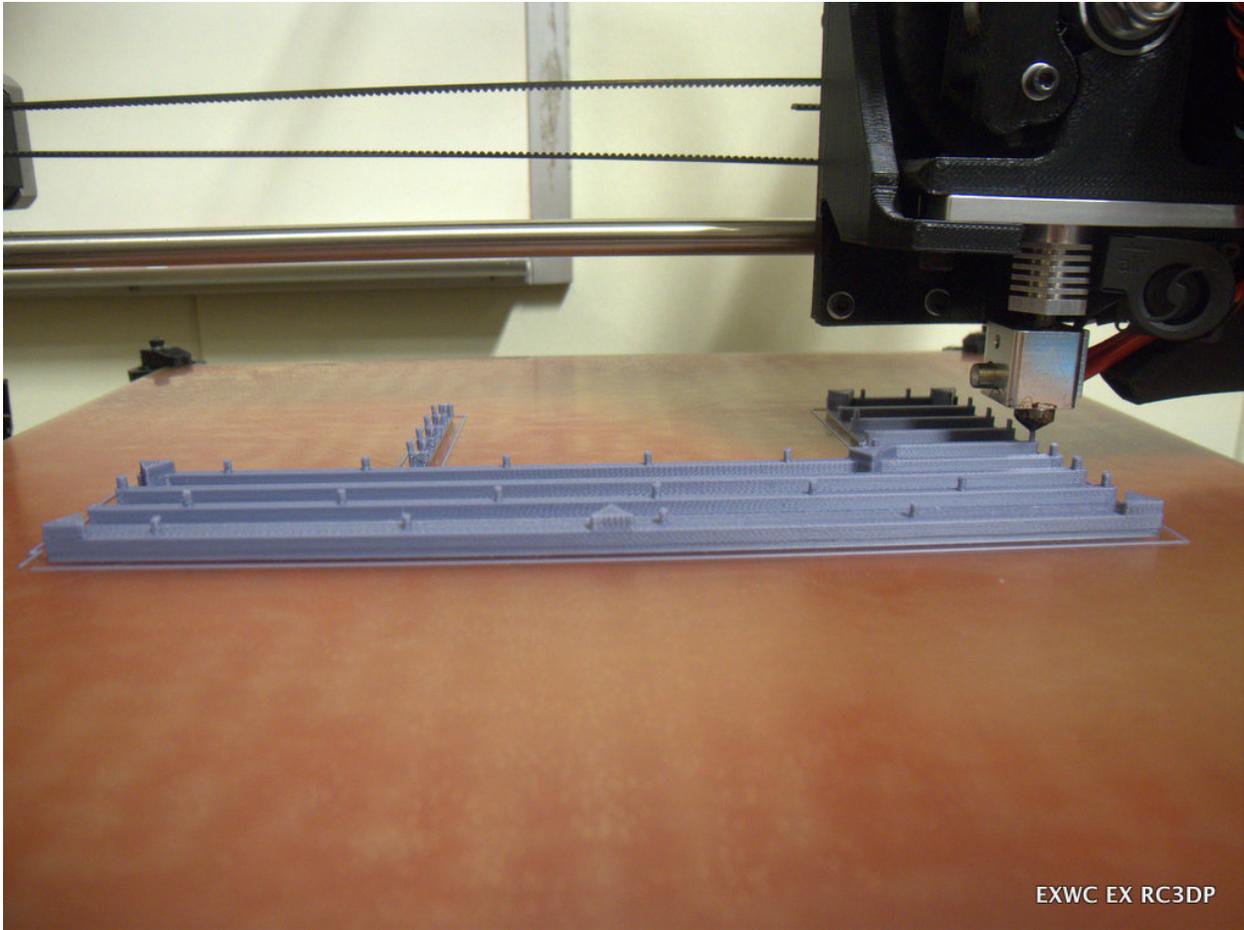
Figure 14: This pier section was printed using HIPS material as a completely solid part.

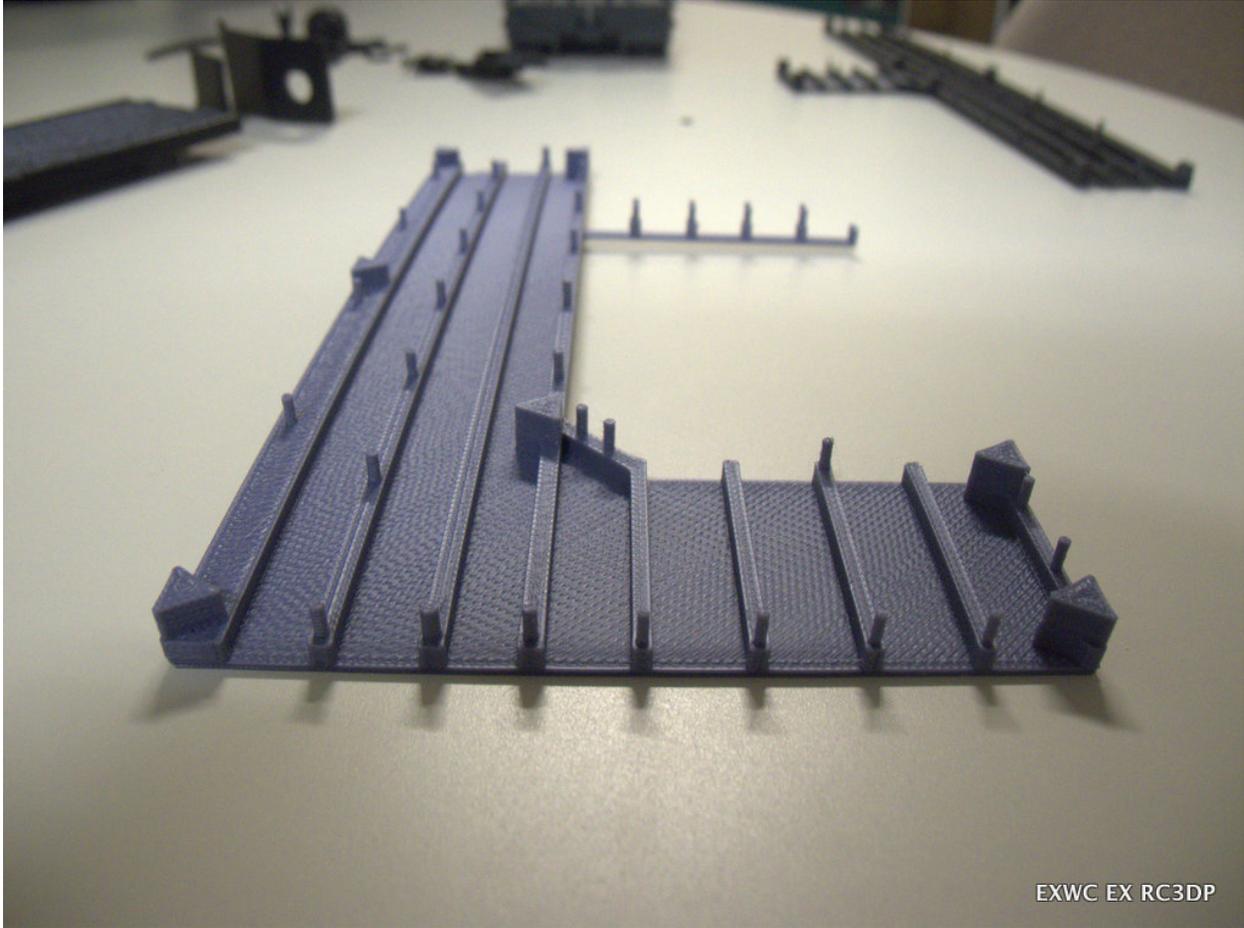
Figure 15: The pier section printed in HIPS is shown as-removed from the machine, exhibiting high finish quality with no deburring required.

figure 15. However HIPS requires a higher extrusion temperature (240 C), and higher bed temperature (110 C) to achieve adhesion. HIPS also exhibits more thermal expansion than PLA. Due to the heated bed, the pier surface was maintained at 110 C while the underside of the pier (the top layers when printed upside down) was exposed to air and cooled in real-time during the course of the print job. On job completion and removal from the build plate, the pier surface cooled and contracted, resulting in a significant warping of the part as shown in figure 16.

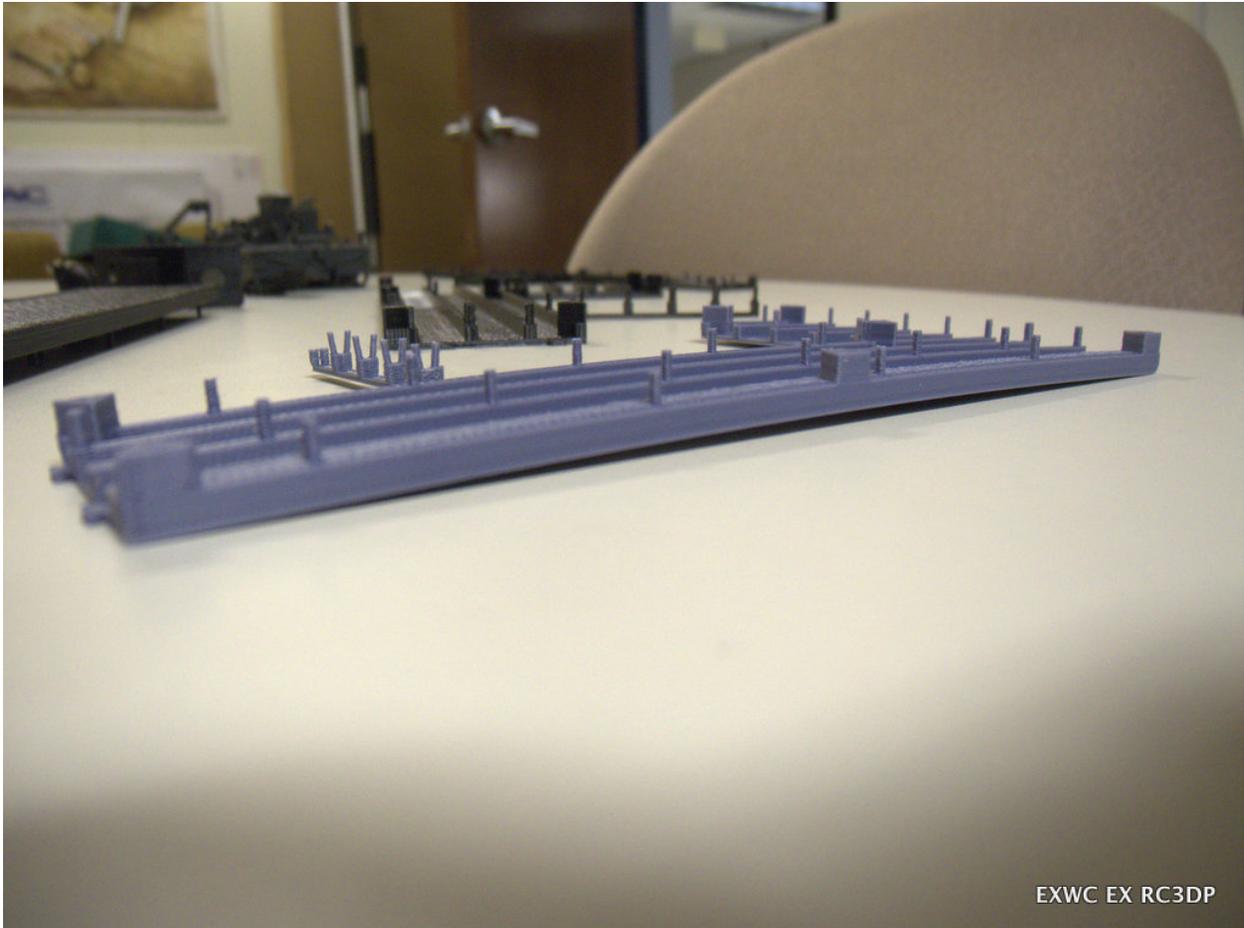
Figure 16: HIPS parts exhibit significant warping due to residual thermal stress from the heated build-plate, causing an uneven temperature profile through the thickness of the part.

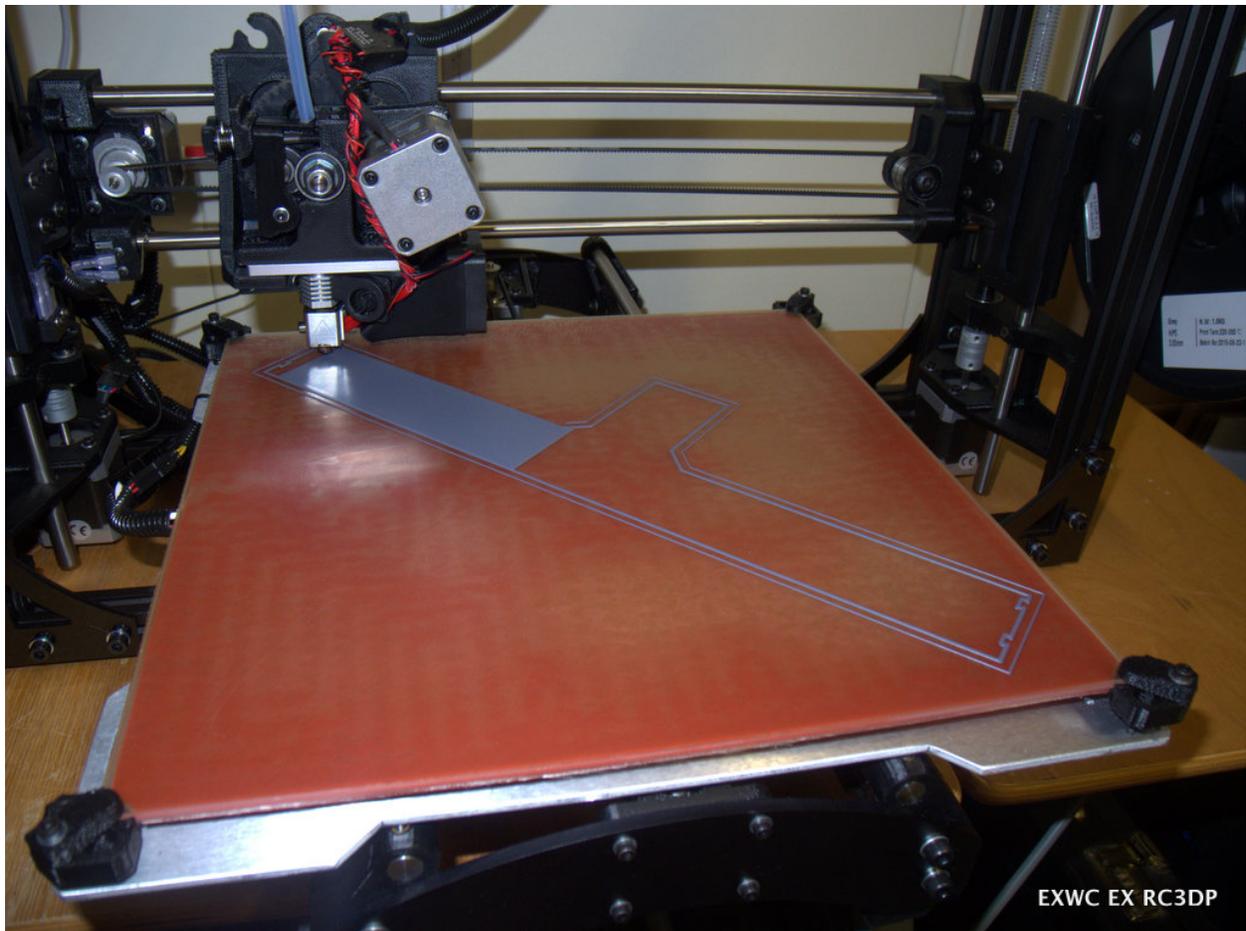
Figure 17: The center section of the pier was printed at a 45-degree angle to maximize the available print area.

Pier Print 9 (TAZ5-0012): The center section of the pier was printed at 0.60x scale, arranged at a 45 degree angle on the build plate, as a solid HIPS part as seen in figure 17. As with the other HIPS pier prints, this part exhibited outstanding quality with no deburring required, however suffered from the same warping phenomenon as seen in figure 18. The warping impaired the ability of the models to mate properly with the interlocking features as shown in figure 19.
