TECHNICAL REPORT
TR-NAVFAC-EXWC-EX-1601
APRIL 2016

**REMOTE COLLABORATIVE 3D PRINTING -
PROCESS INVESTIGATION**

Cody M. Reese, PE

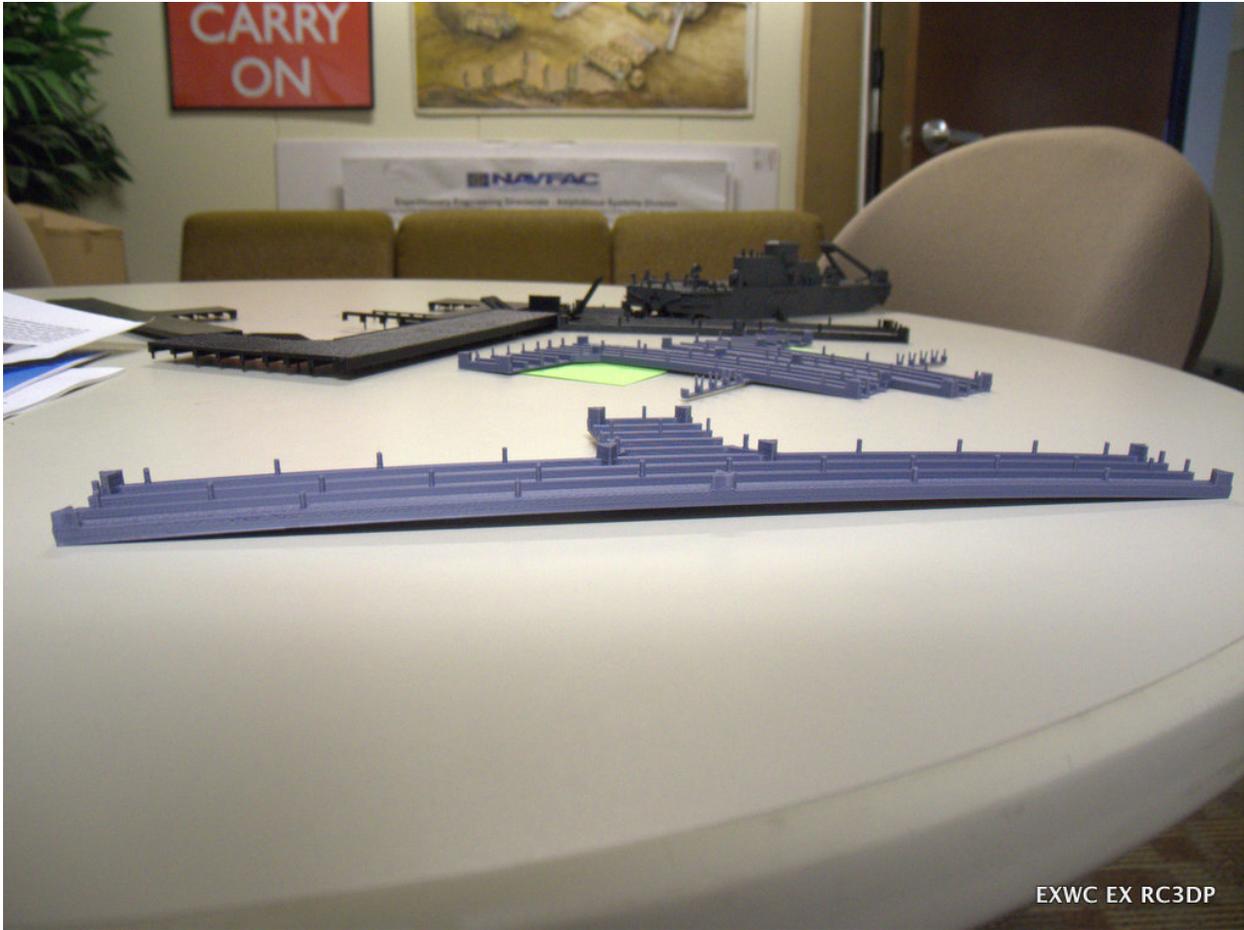
Figure 18: Extreme warping caused by residual thermal stress can be seen in the long, center section of the pier.

Pier Print 9 (TAZ5-0012): The center section of the pier was printed at 0.60x scale, arranged at a 45 degree angle on the build plate, as a solid HIPS part as seen in figure 17. As with the other HIPS pier prints, this part exhibited outstanding quality with no deburring required, however suffered from the same warping phenomenon as seen in figure 18. The warping impaired the ability of the models to mate properly with the interlocking features as shown in figure 19.

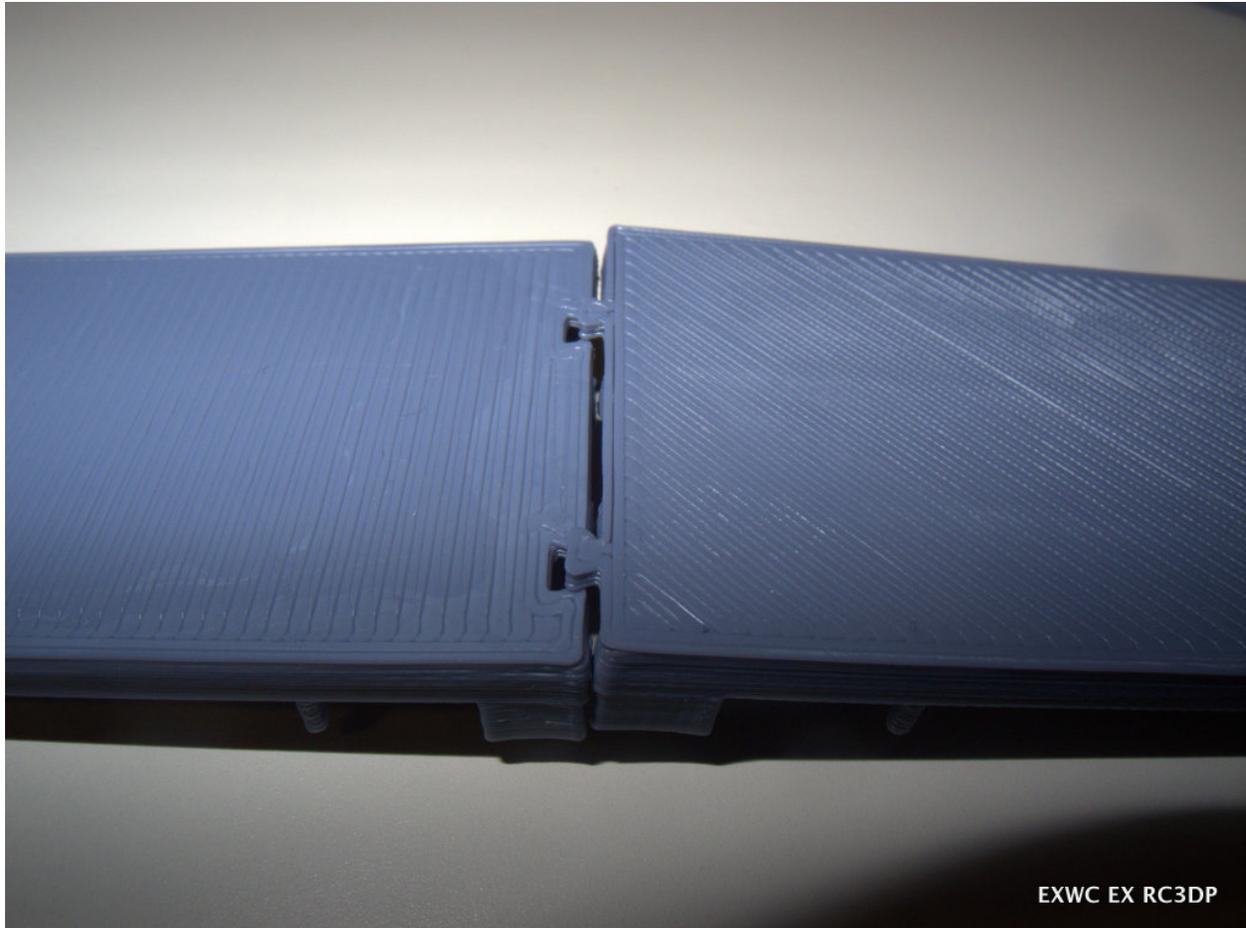
Figure 19: The warping caused by residual thermal stress, and dimensional overruns did not allow mating of the model sections without manual rework.

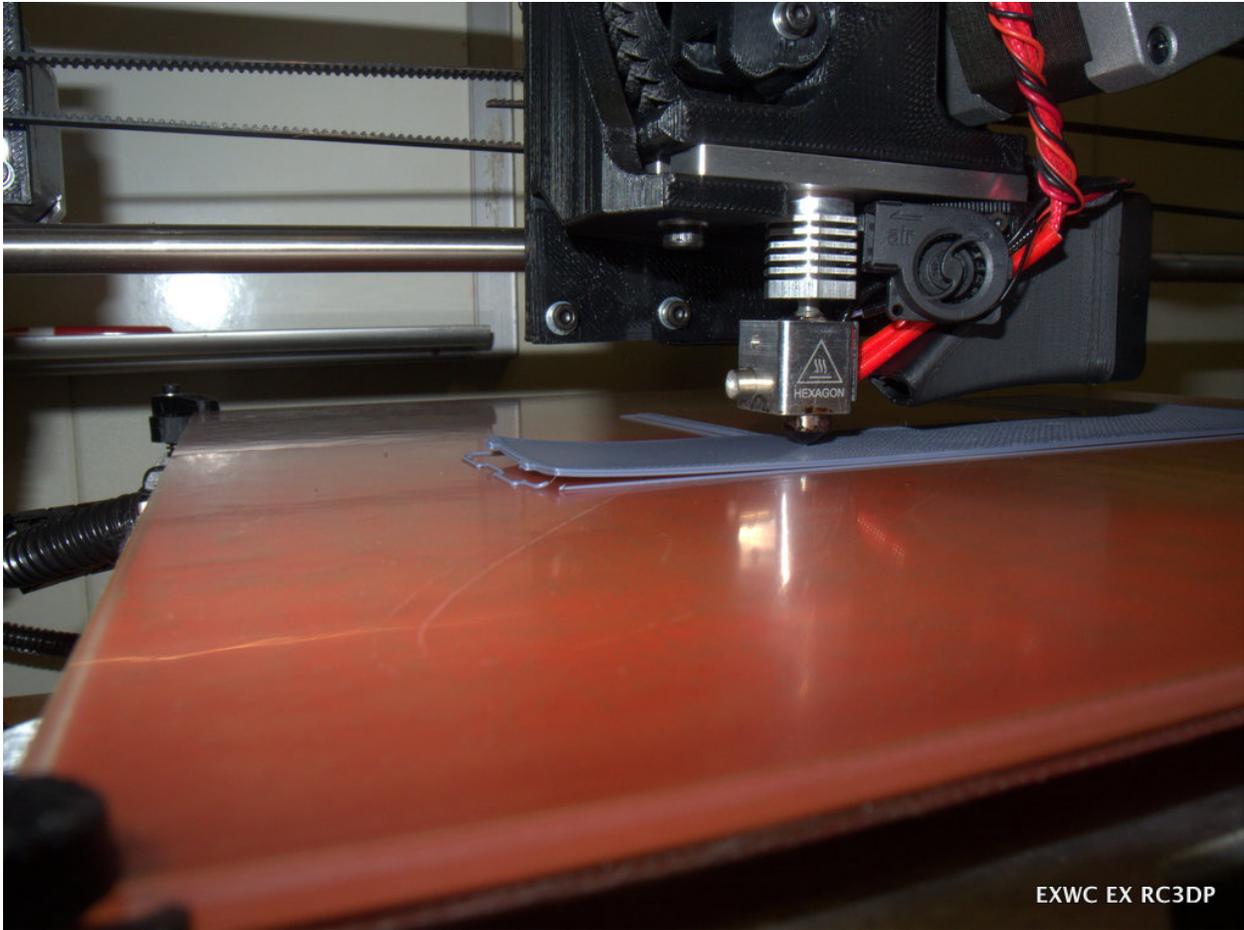
Figure 20: Early adhesion failure was evident on print attempts at reduced bed temperatures.

Pier Print 10 (TAZ5-0013, 0014): In an attempt to mitigate the warping of the HIPS pier prints, a print of the pier end was attempted with the bed temperature of 60 C. Almost immediately, it was clear that the first layer of the print was not adhering to the build surface and was peeling up at the corners, as seen in figure 20 and 21. The peeling was exacerbated as additional layers were deposited, and the print was canceled. The print was re-attempted with a bed temperature of 80 C, however the same bed-adhesion failure mode was observed.

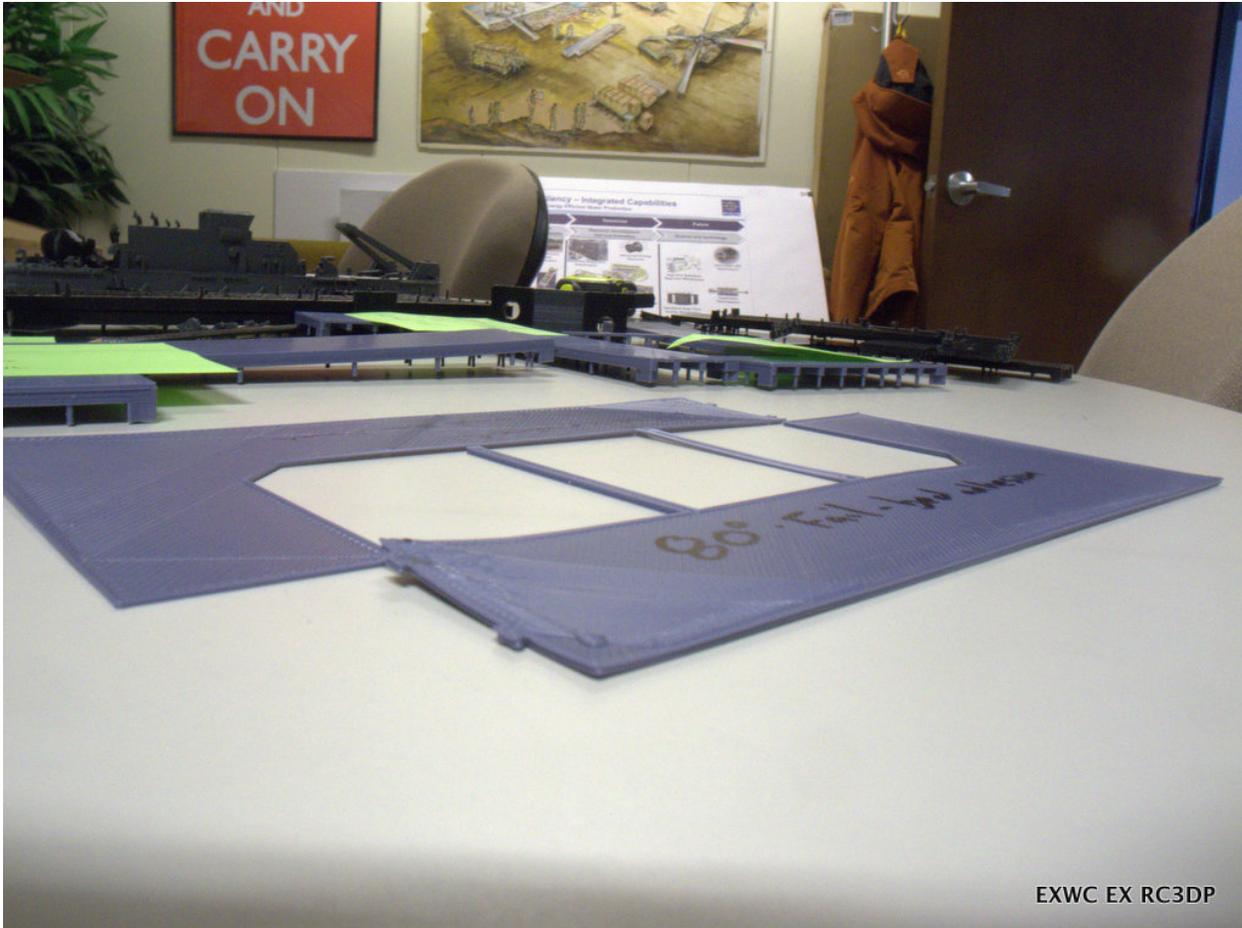
Figure 21: Attempts to print HIPS parts at reduced bed temperatures resulted in adhesion failures.

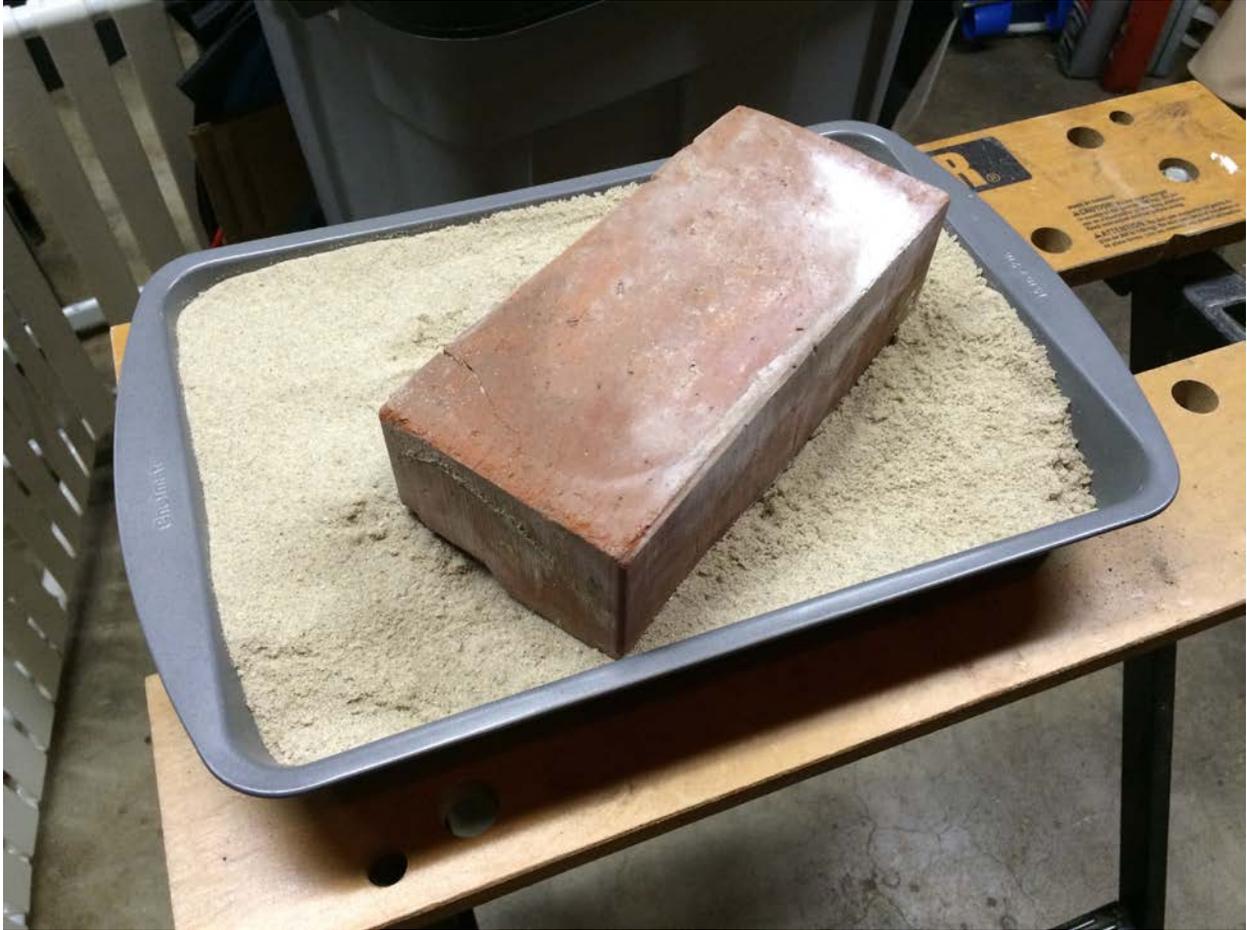
Figure 22: Warped parts were annealed under a weight in a bed of sand to control heat transfer rate and ensure uniform cooling.

Pier post processing: The pier sections as printed would not fit together as designed with the interlocking features. All sections required minor work with a file to remove material overruns and achieve proper mating and assembly. Additionally, it was determined that HIPS parts were able to be flattened through an annealing process for stress relief. A pier section was flattened in a baking pan under a weight (brick), and surrounded by sand to control heat transfer rate, as shown in figure 22. The assembly was baked in an oven at approximately 100 C for an hour, then removed and allowed to air cool. Once cool, the HIPS part was removed from the sand, and revealed to have been effectively straightened as shown in figure 23. Once the pier sections were flattened via the annealing process and the interlocking features were filed to remove excess material, the pier sections fit together precisely, as shown in figures 24 and 25.

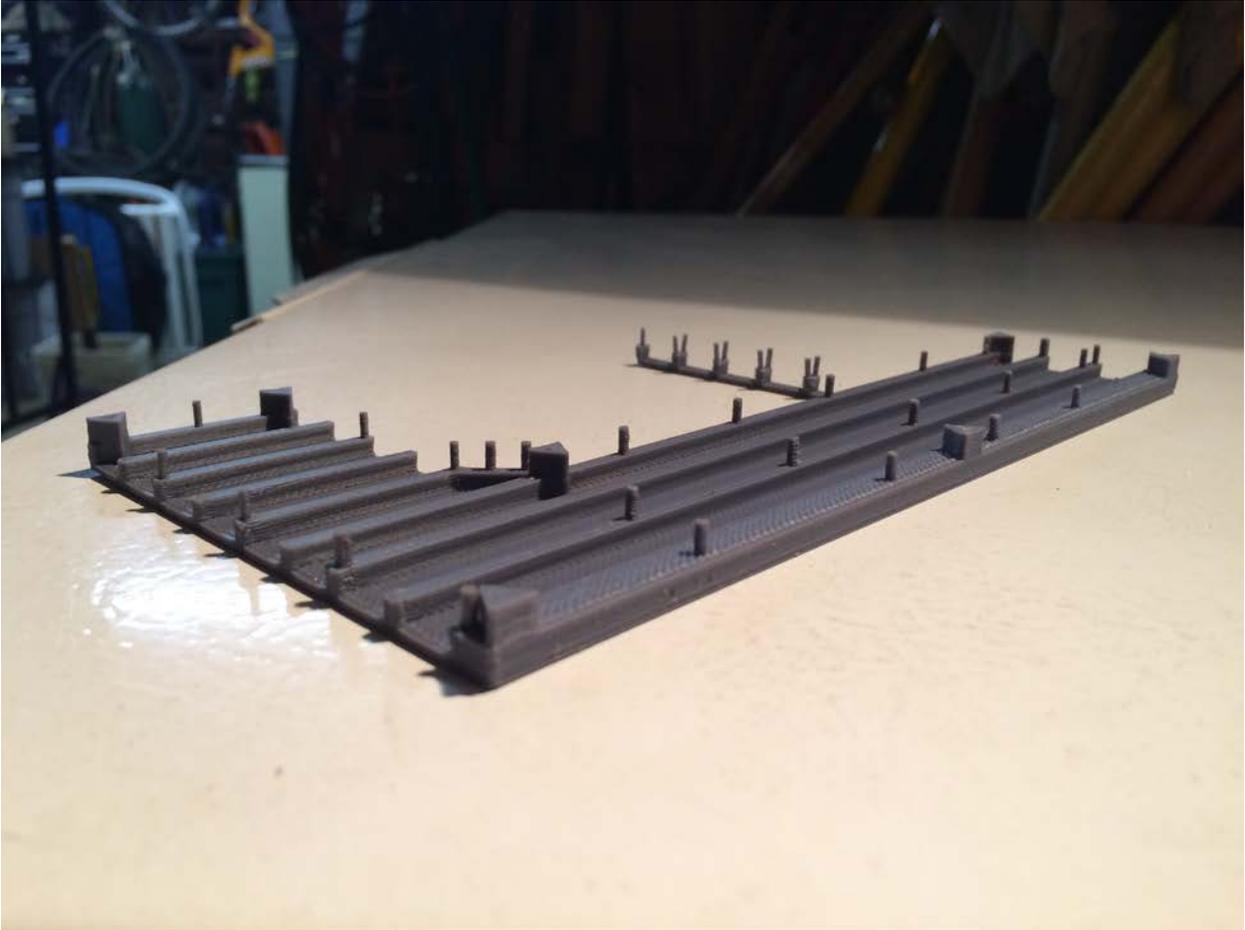
Figure 23: The annealing process successfully flattened the pier, eliminating the residual thermal stress.

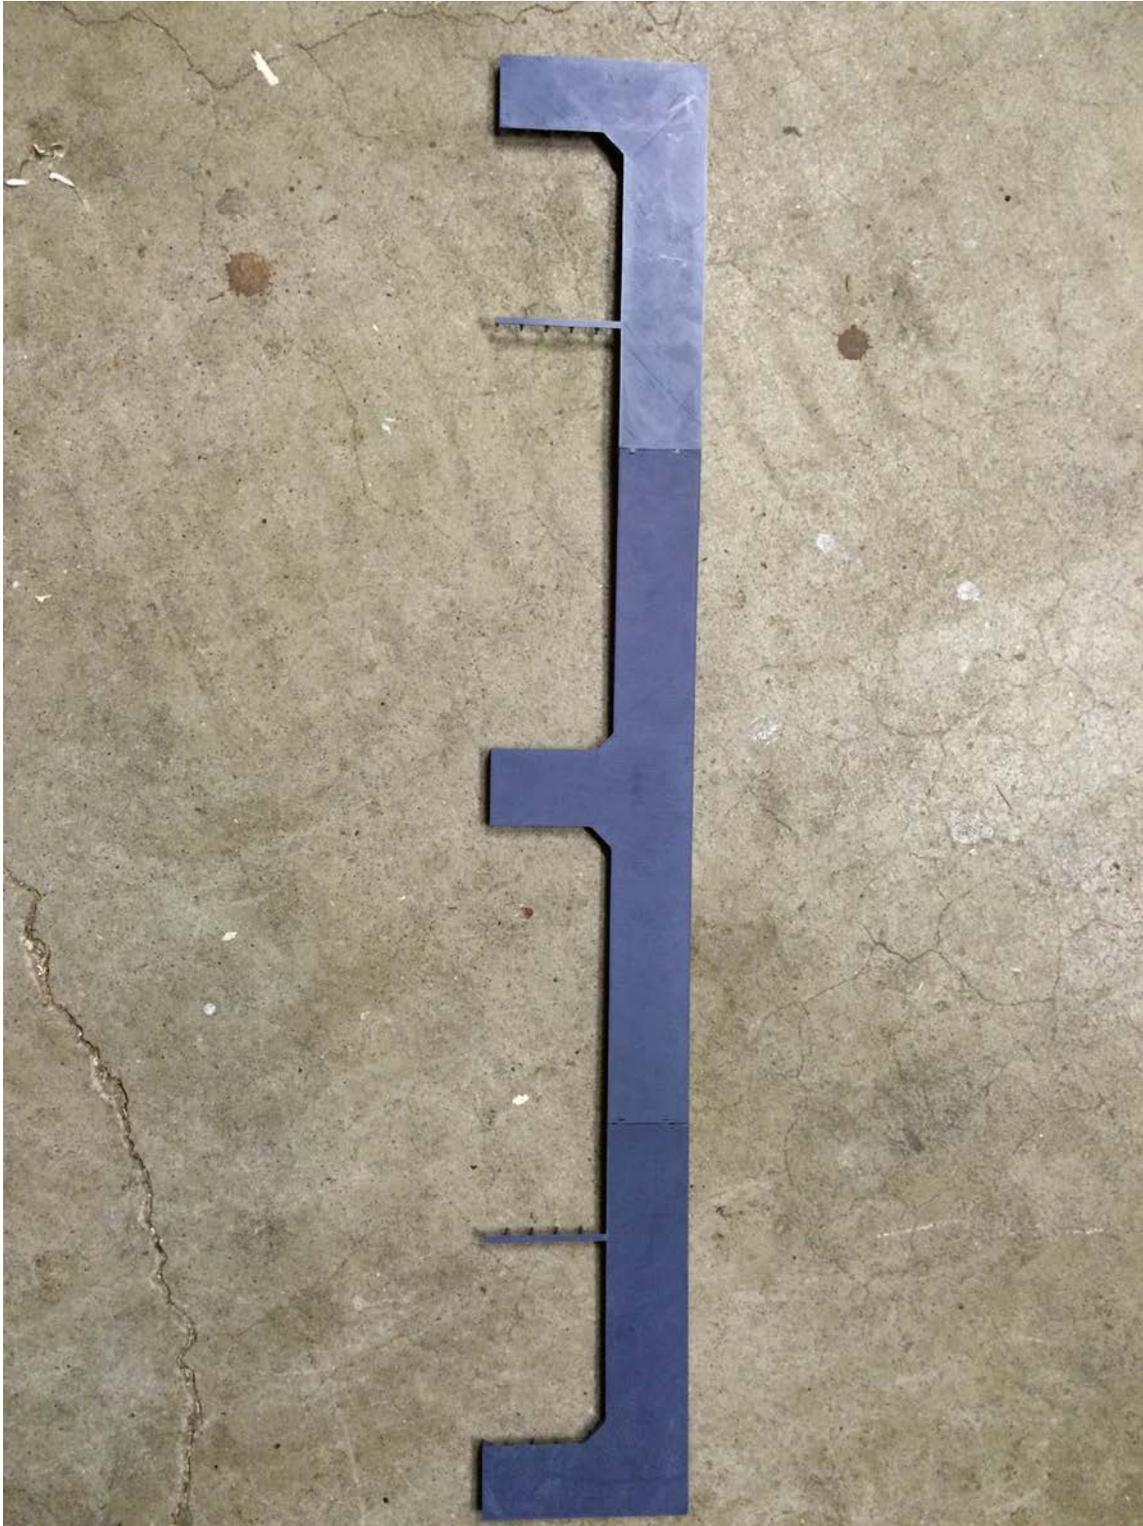
Figure 24: The complete pier assembly was assembled after manual fitting and shaping of the interlocking features for proper fitment.

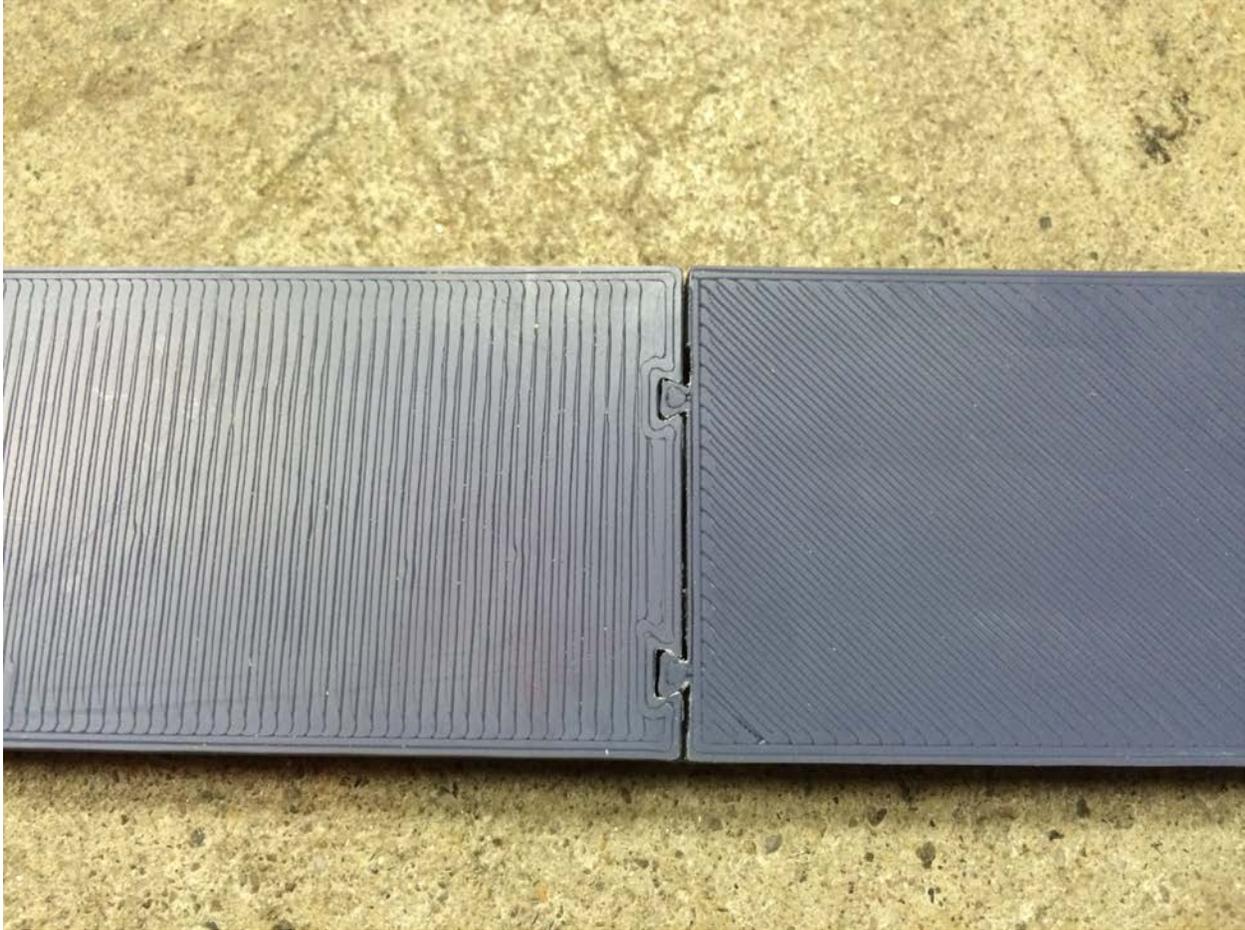
Figure 25: Finishing and deburring of the interlocking features was required to facilitate model connection.

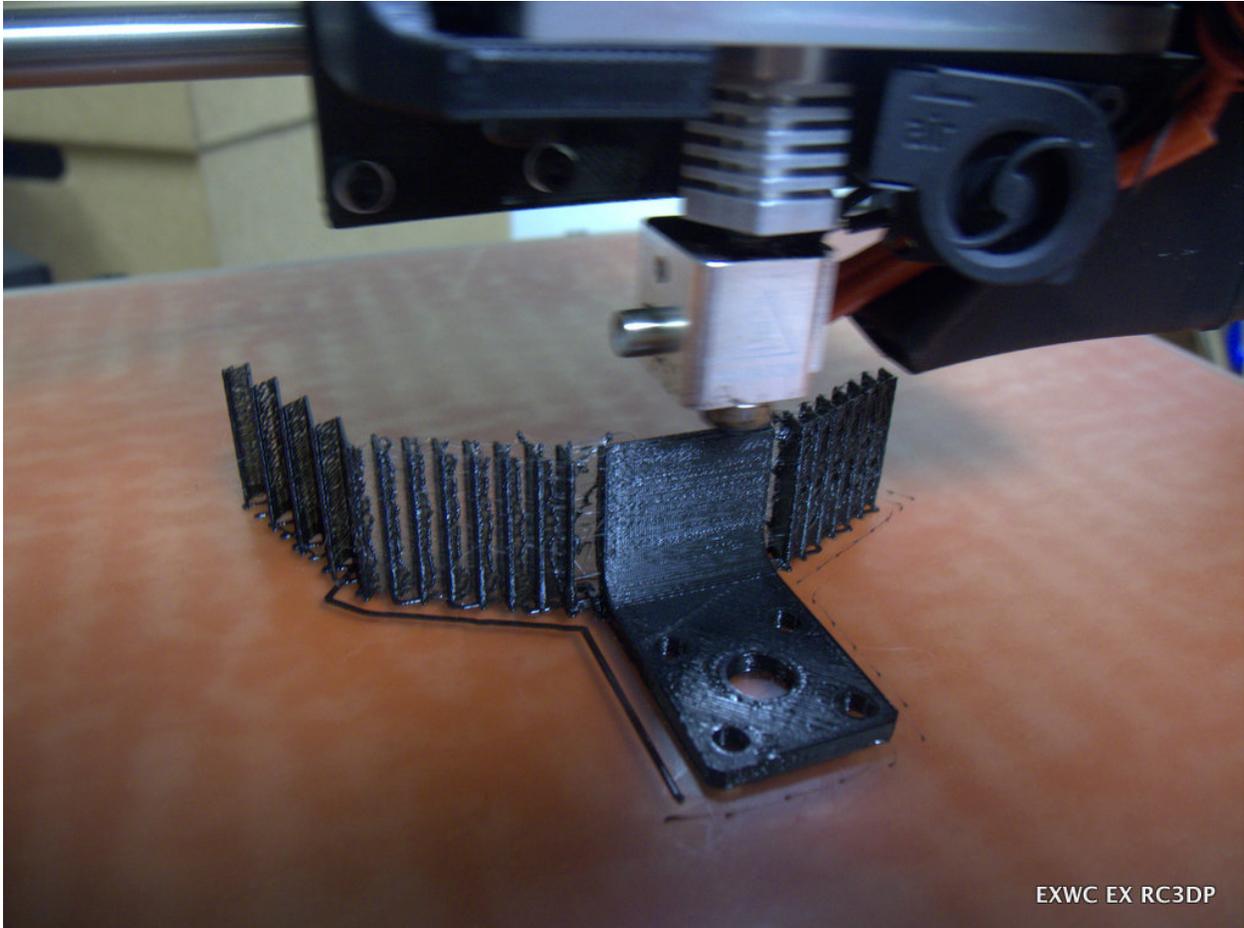
Figure 26: The partially printed fire extinguisher bracket shows primary and support structure being produced from the same material.

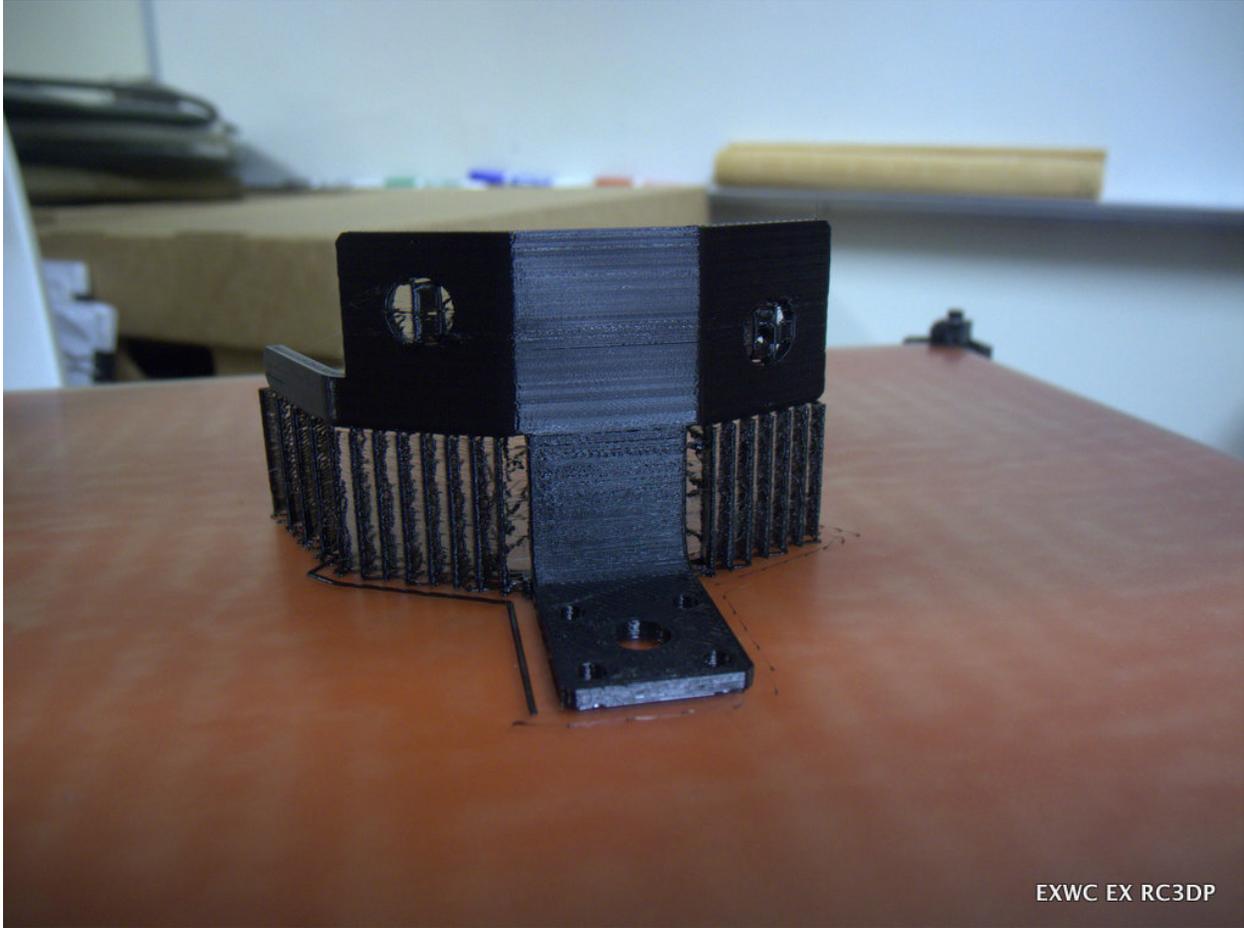
Figure 27: The fire extinguisher bracket print from PLA on the TAZ5 shows the use of same-material support structures.

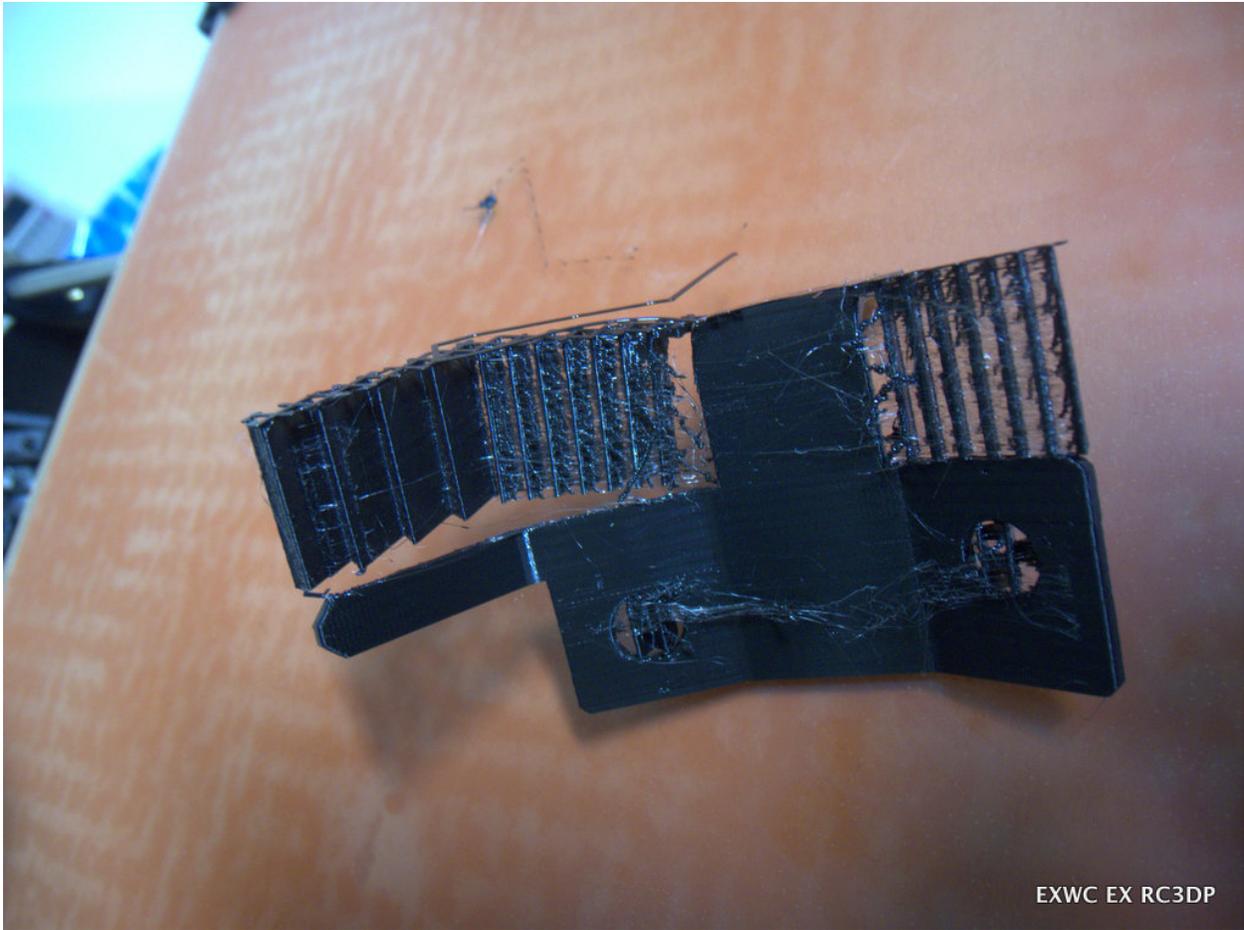
Figure 28: Deburring of the completed fire extinguisher bracket includes removal of the support material.

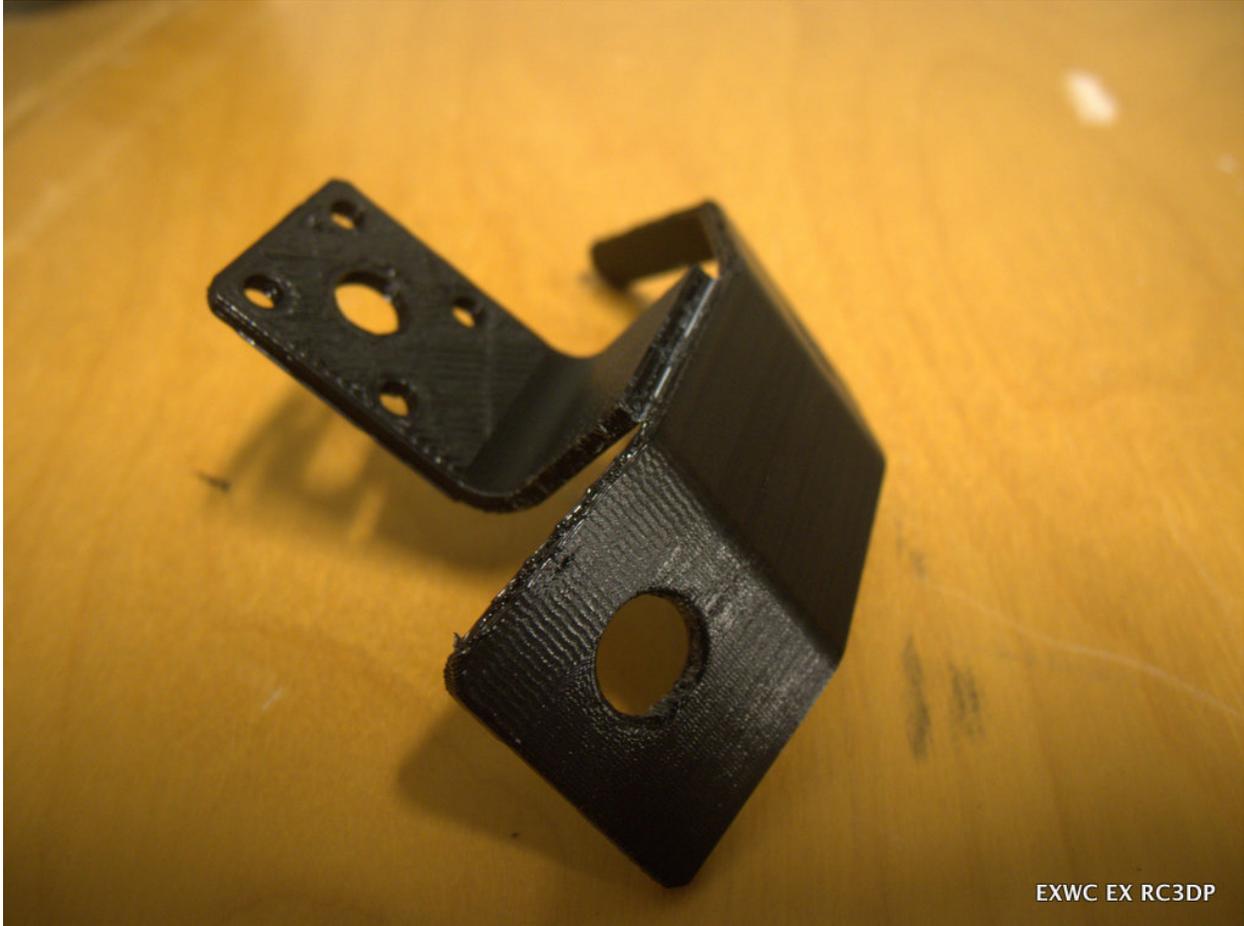
Figure 29: The fire extinguisher bracket broke along a layer interface at a high-stress area, in spite of delicate handling.

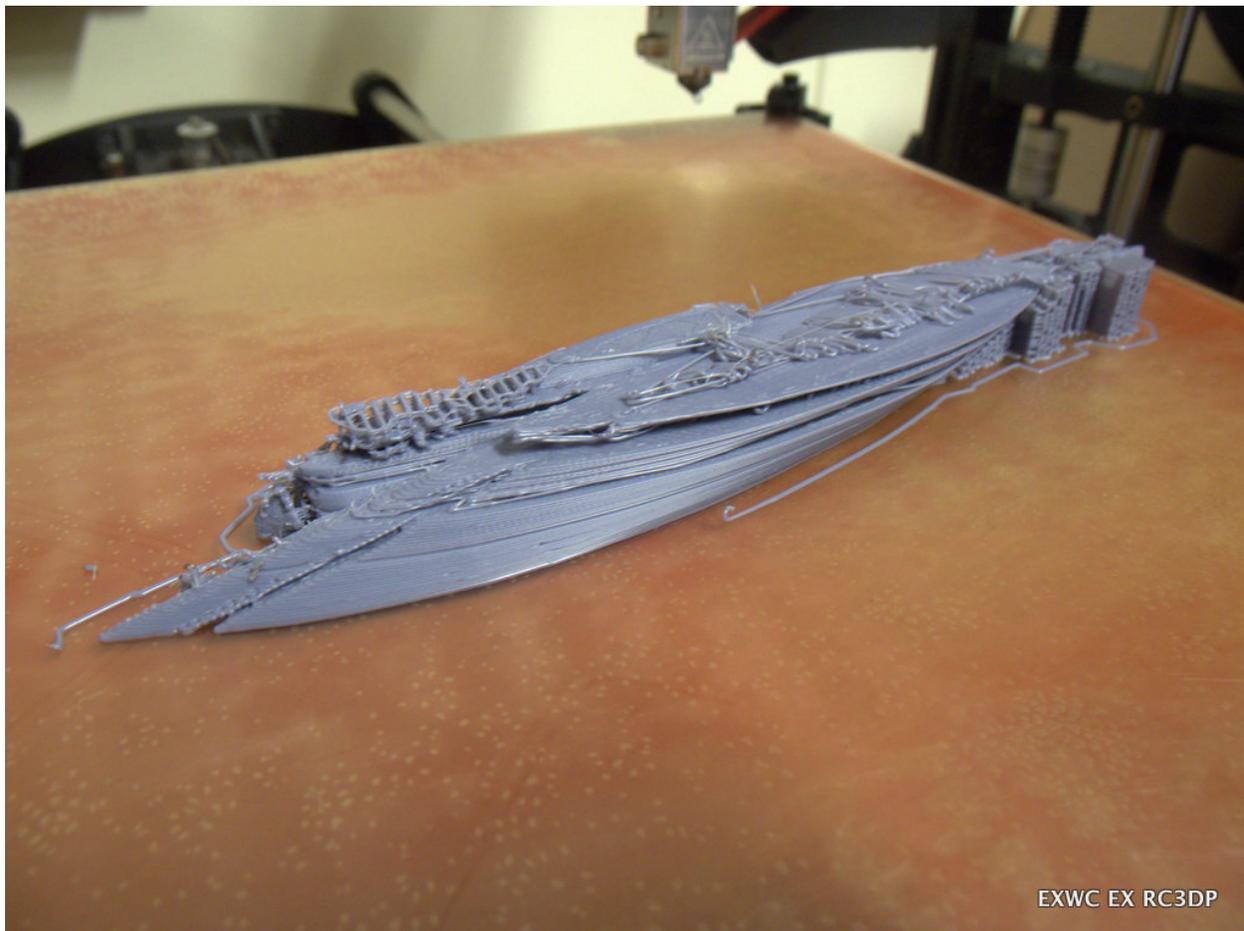
Figure 31: This print of an I-400 submarine model sourced from the Sketchup 3D Warehouse failed due to missing layers resulting from the conversion from a shell to solid model.

(TAZ5-0015): As we were unable to generate a file suitable for printing the Ohio Replacement sub, we attempted to download a submarine model from the Sketchup 3D warehouse online repository. An I-400 class Japanese submarine was chosen due to the apparent high quality of the model. The .skp model file was downloaded, opened with Sketchup, and exported as a .obj file. The .obj was imported into Cura and prepared for print. The original file was revealed to be a surface model, with several open features. Though Sketchup attempted to patch the holes on the .obj export operation, the file still had issues apparent in Cura. When generating g-code, several of the print layers were simply missing. An attempt was made to print the model anyway, and a few of the smaller layer gaps were overcome successfully, however the print totally failed when a large layer gap was encountered as shown in figure 31.

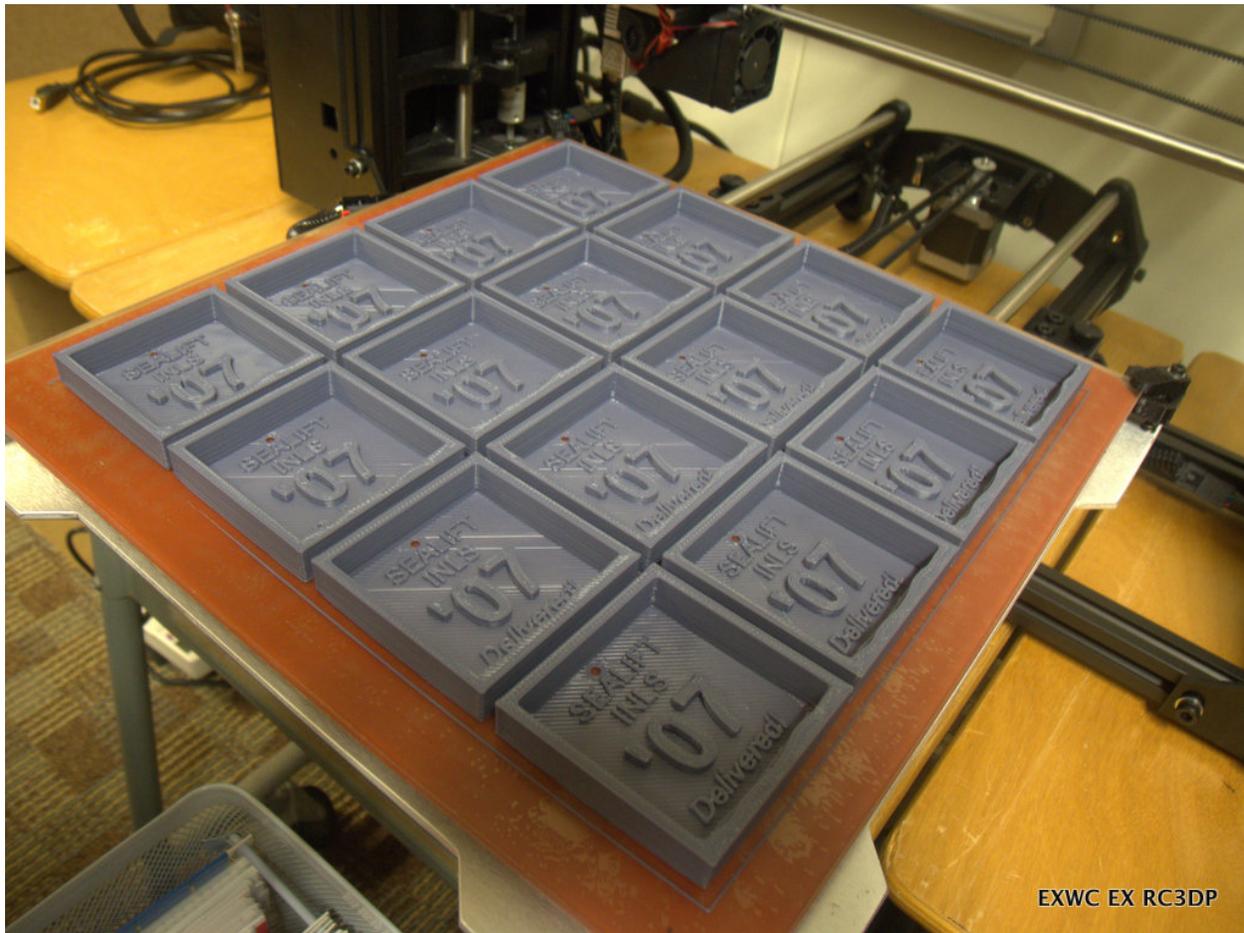
Figure 32: Batch prints of 16 identical part files were produced to evaluate production consistency.

(TAZ5-0016, 0017, 0018): A small shadowbox award for an EXWC high-performing project team was generated in the free Autodesk “123D Design” CAD package (.123dx file format). This model was exported as a .stl file from 123D, and imported with Cura. Cura was able to manipulate the file with no issues. Several versions were printed, with the final print (0018) being a batch-print of 16 parts simultaneously as shown in figure 32. The batched parts came out well, however they all exhibited some bed adhesion failure at the corners despite the 110 C bed temperature, as shown in figure 33.

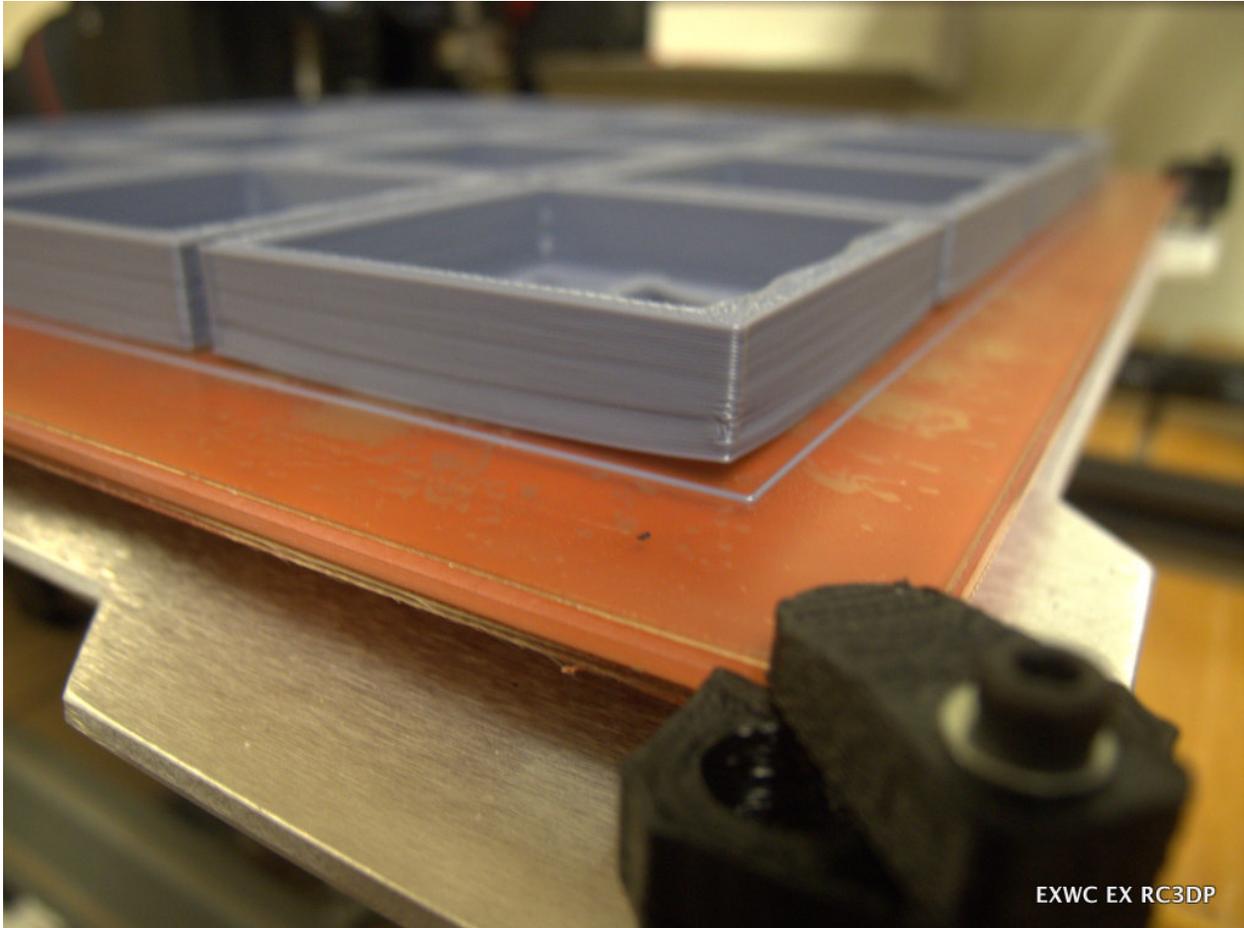
Figure 33: The batch print of the award shadowboxes revealed minor bed adhesion failure on many of the individual pieces.

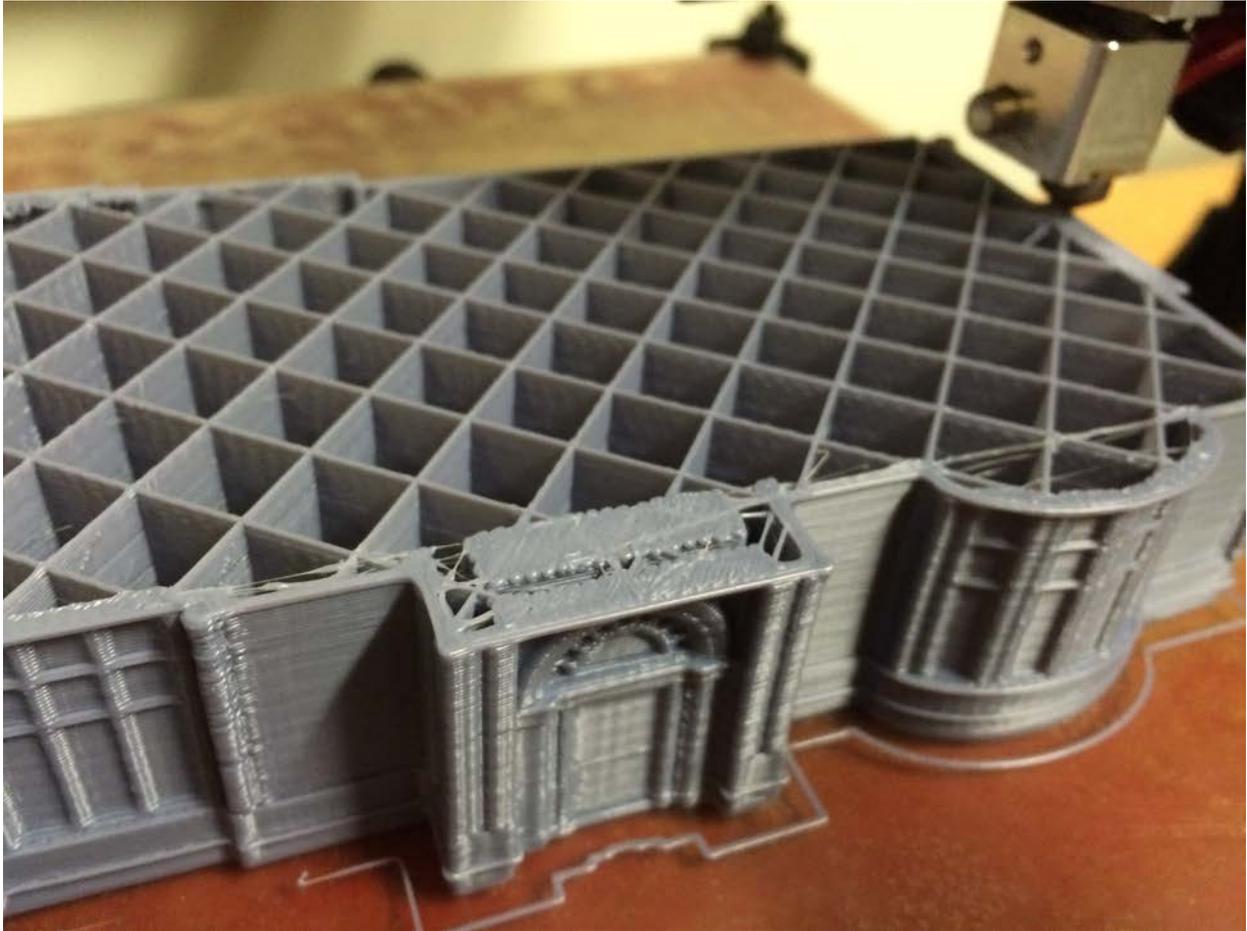
Figure 34: This view of the partially completed Vanderbilt mansion print shows a door header which was successfully bridged without support material, enabled by the fast print speed and thick filament extrusion.

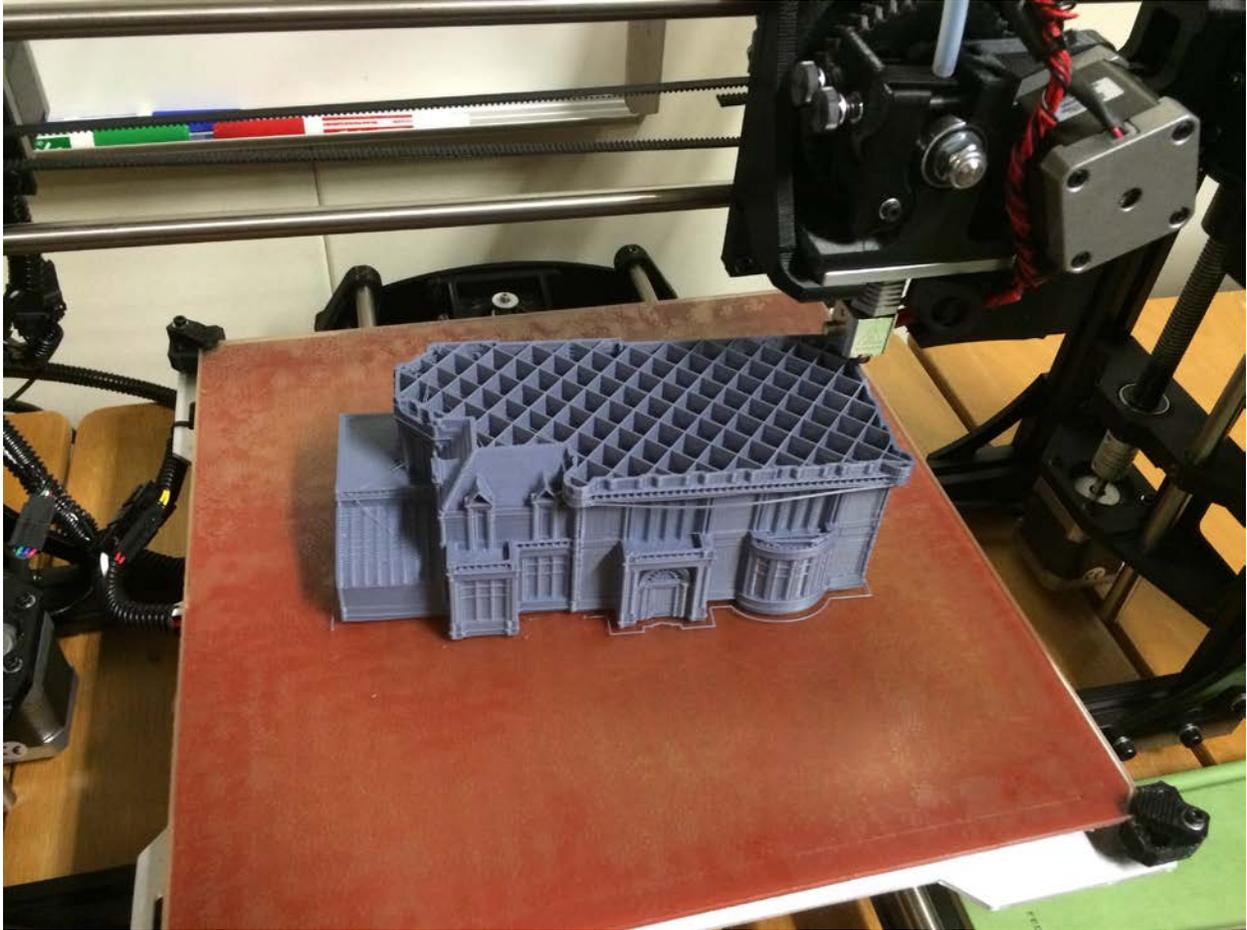
Figure 35: This image of the partially complete Vanderbilt mansion shows the uniform internal support structure.

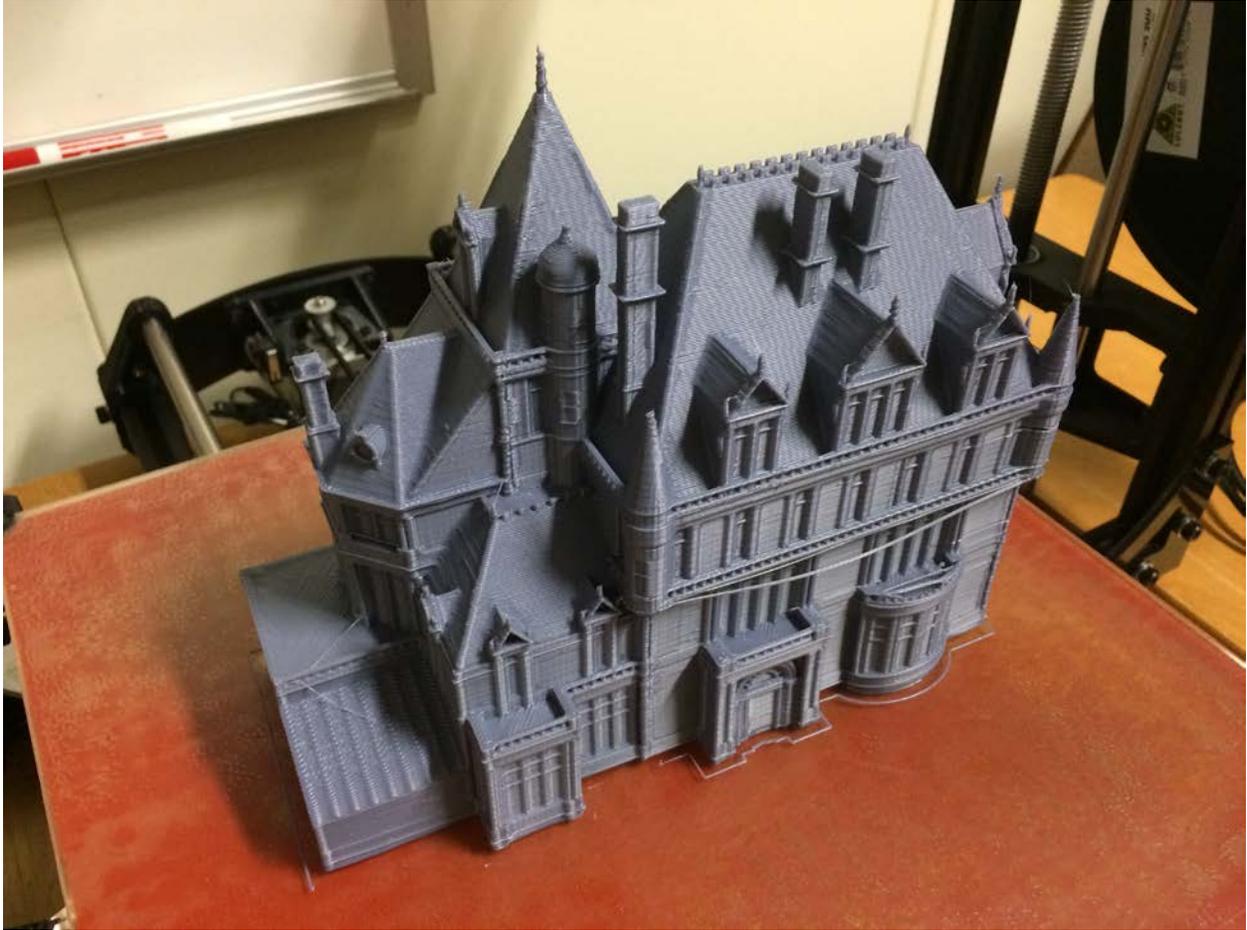
Figure 36: The completed Vanderbilt mansion print is the largest print to-date on the TAZ5 printer at EXWC.
