TECHNICAL REPORT
TR-NAVFAC-EXWC-EX-1601
APRIL 2016

**REMOTE COLLABORATIVE 3D PRINTING -
PROCESS INVESTIGATION**

Cody M. Reese, PE

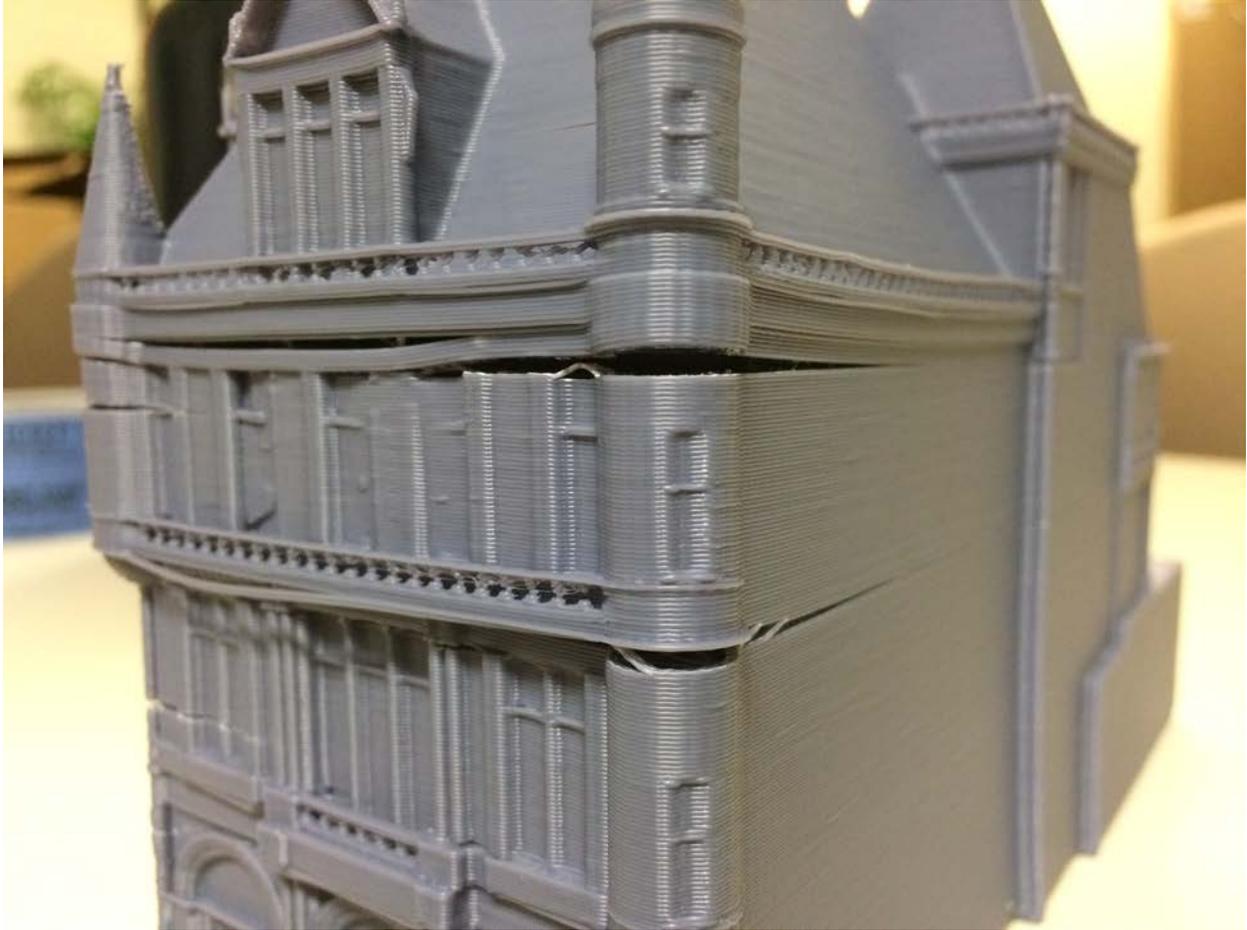
Figure 38: The surface detail of Vanderbilt mansion shows cracking and delamination, likely as a result of thermal stresses and poor layer adhesion at fast print speeds without optimized or adjusted temperature parameters.

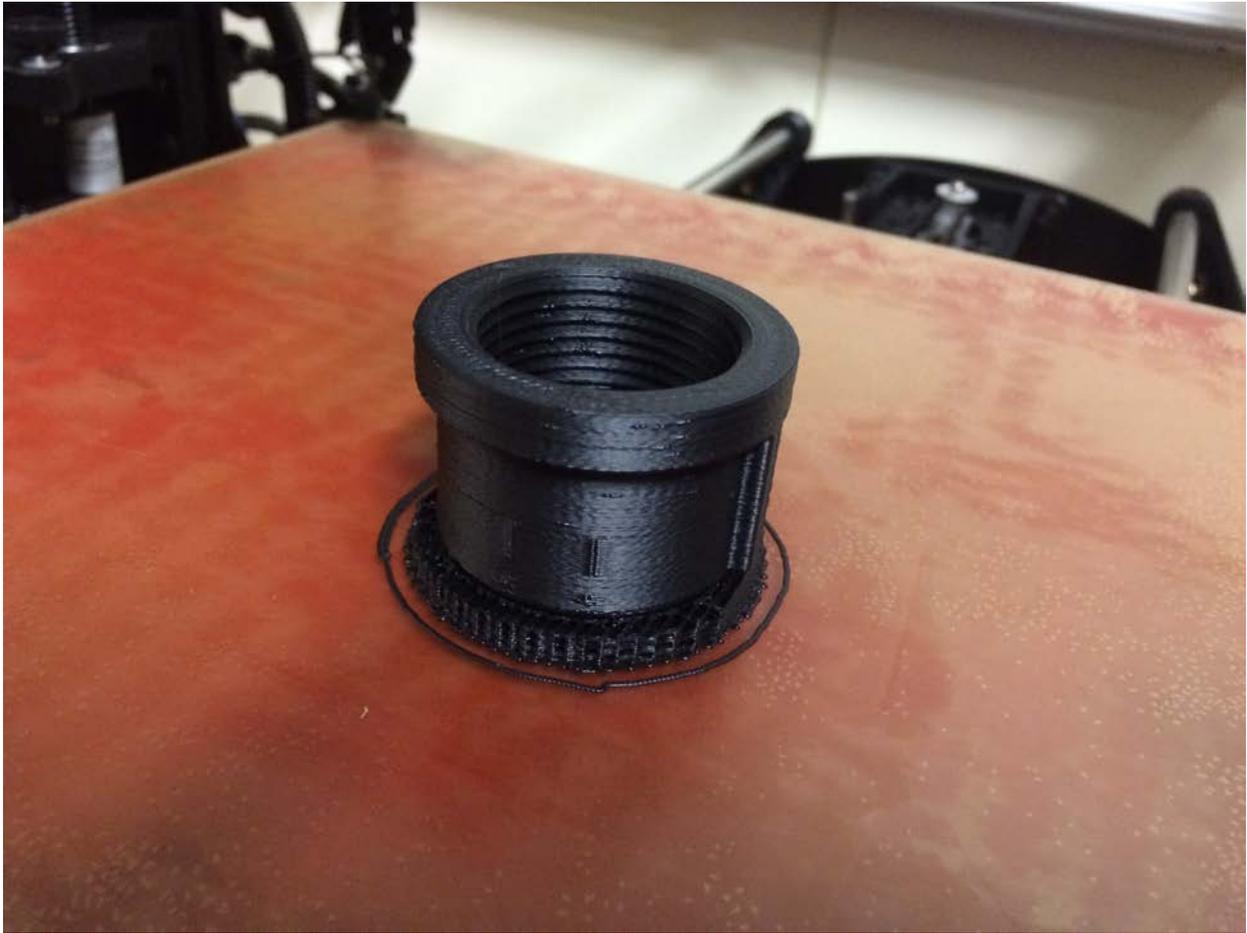
Figure 39: This pipe end cap was downloaded as a model file from McMaster Carr, and printed in ABS plastic on the TAZ5.

(TAZ5-0030): McMaster Carr is a large industrial and commercial supply company with an extensive catalogue of tools and parts. McMaster.com provides free downloadable solid models of many of the parts that they stock and sell. To evaluate a variation of the digital workflow, a small part was chosen to be downloaded and printed. A pipe end cap was selected as a small part, with specific dimensional requirements, and interesting features such as threads. The part was downloaded as a STEP file, opened in Autodesk 123D design, exported as a .stl file, prepared in Cura, and printed without any issue as shown in figure 39. The part was printed as a complete solid with no fractional infill. The internal threads were able to be printed without any support material. Note: this part was purely a workflow and complex-feature print experiment and is NOT intended for, nor capable of use as an actual pipe end cap. Given the print orientation, inter-layer bond strength, and porosity of printed material, the finished part is not suitable for actual use. This serves as a perfect example of a potential danger of inexpensive, distributed advanced manufacturing technologies. Just because one can print something does not mean that one should, and a non-engineer may unknowingly print a replacement part or component that does not meet the appropriate design requirements.

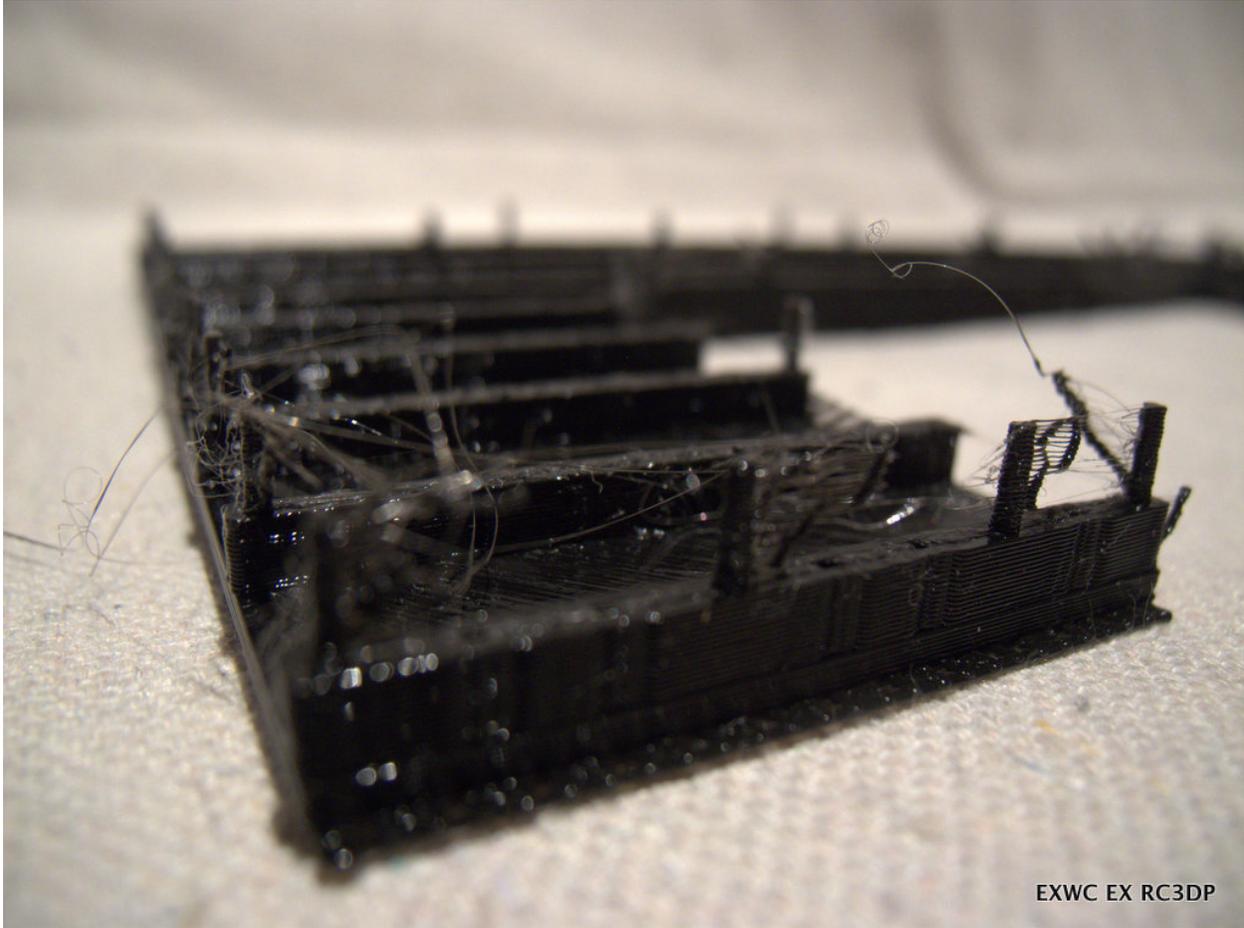
Figure 40: Early PLA prints resulted in extensive flash and filament trails, requiring significant deburring.

- PLA prints exhibited a smooth, shiny surface finish, however small features exhibited by residual flash, requiring extensive deburring as shown in figure 40. Additionally, printing with PLA resulted in noxious fumes near the printer, highlighting the need for appropriate ventilation and environmental conditioning of the workspace.
- HIPS prints exhibited a smooth, high quality surface finish and no flash or other undesired residuals as shown in figure 41. Print operations produced very little odor.
- ABS prints exhibited a clean surface finish with very little flash or other undesired residuals as shown in figure 42. Print operations produced very little odor.

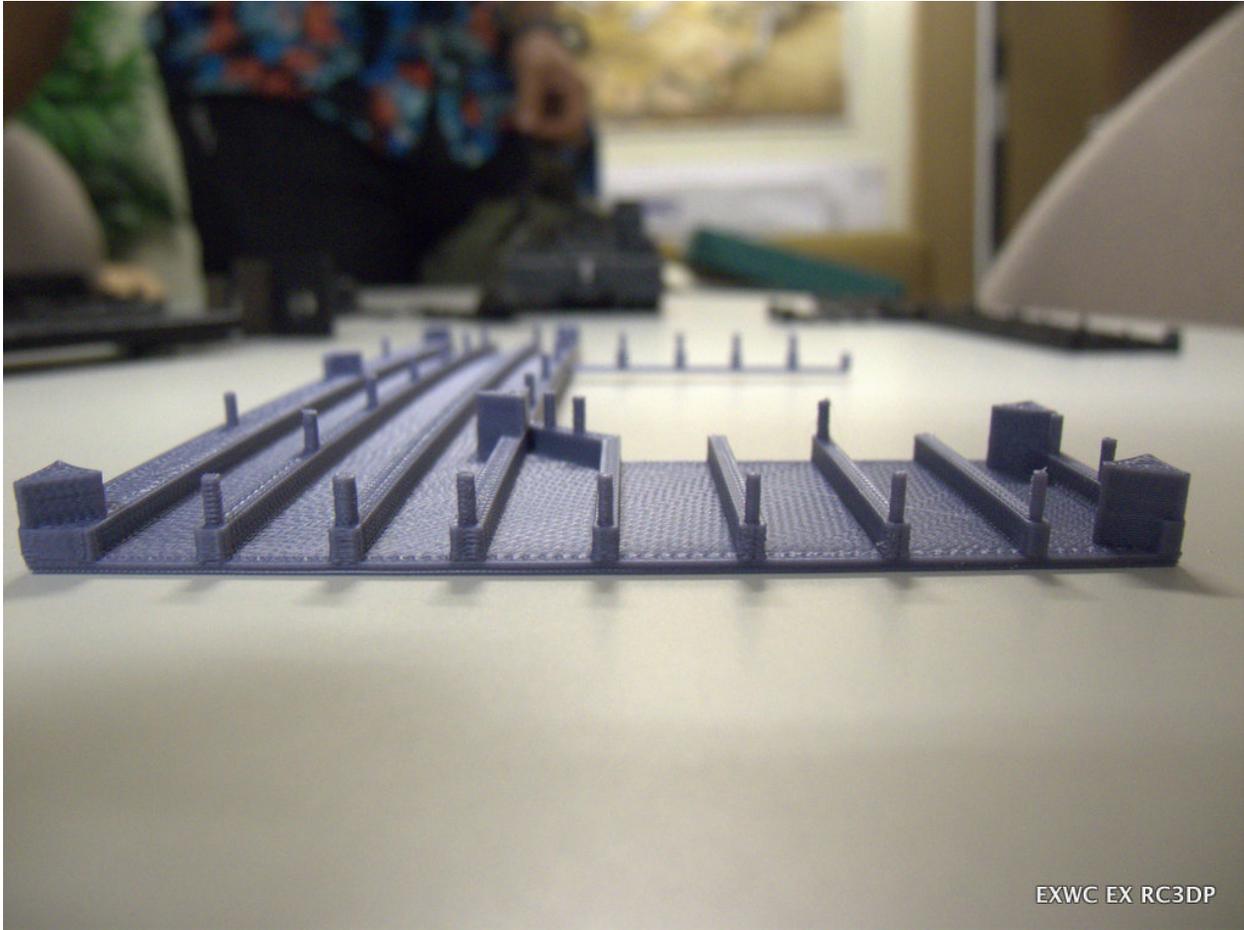
Figure 41: This HIPS print shows an extremely clean finish requiring no deburring.

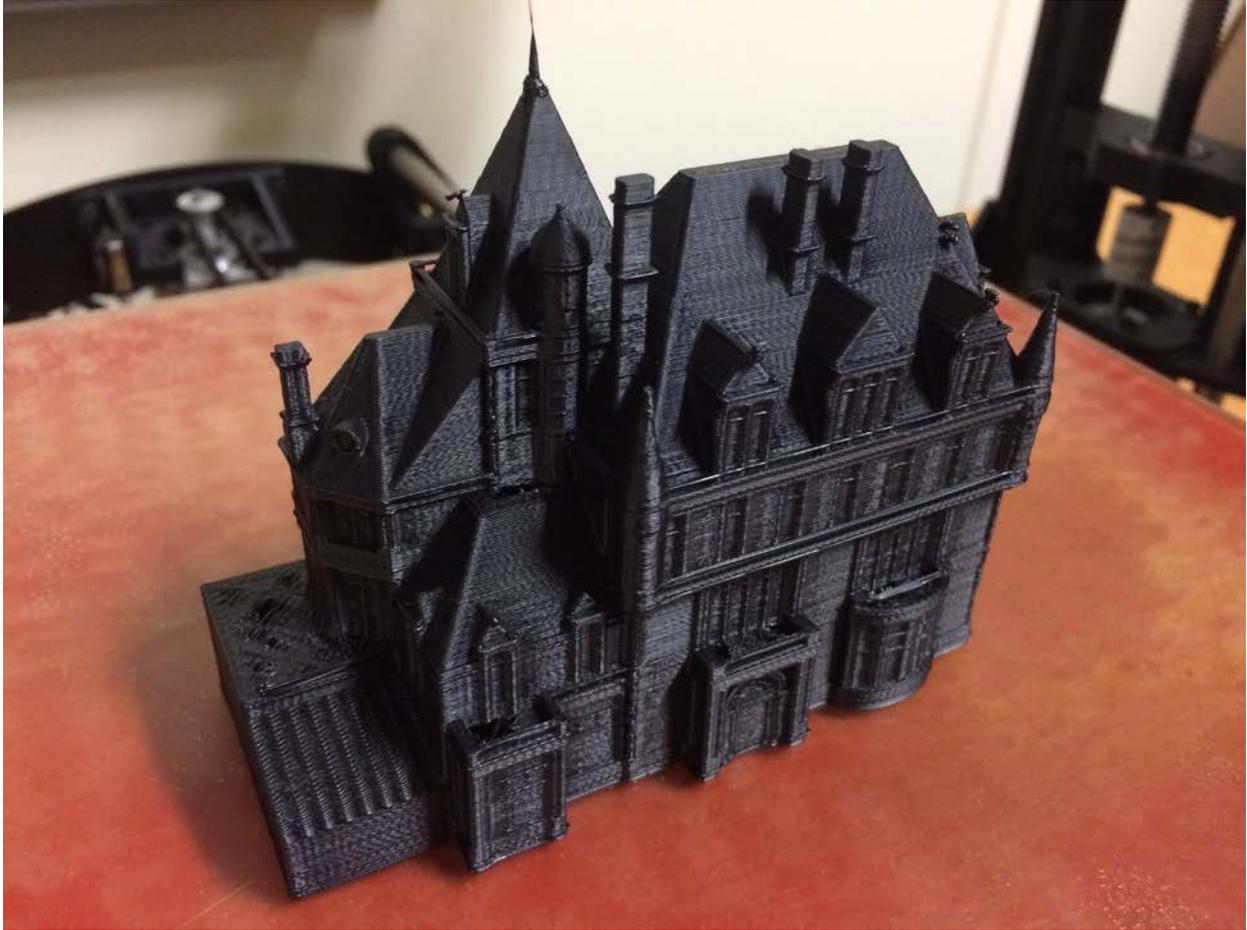
Figure 42: This small ABS print of the Vanderbilt mansion shows good surface finish and no flash or other production residuals.

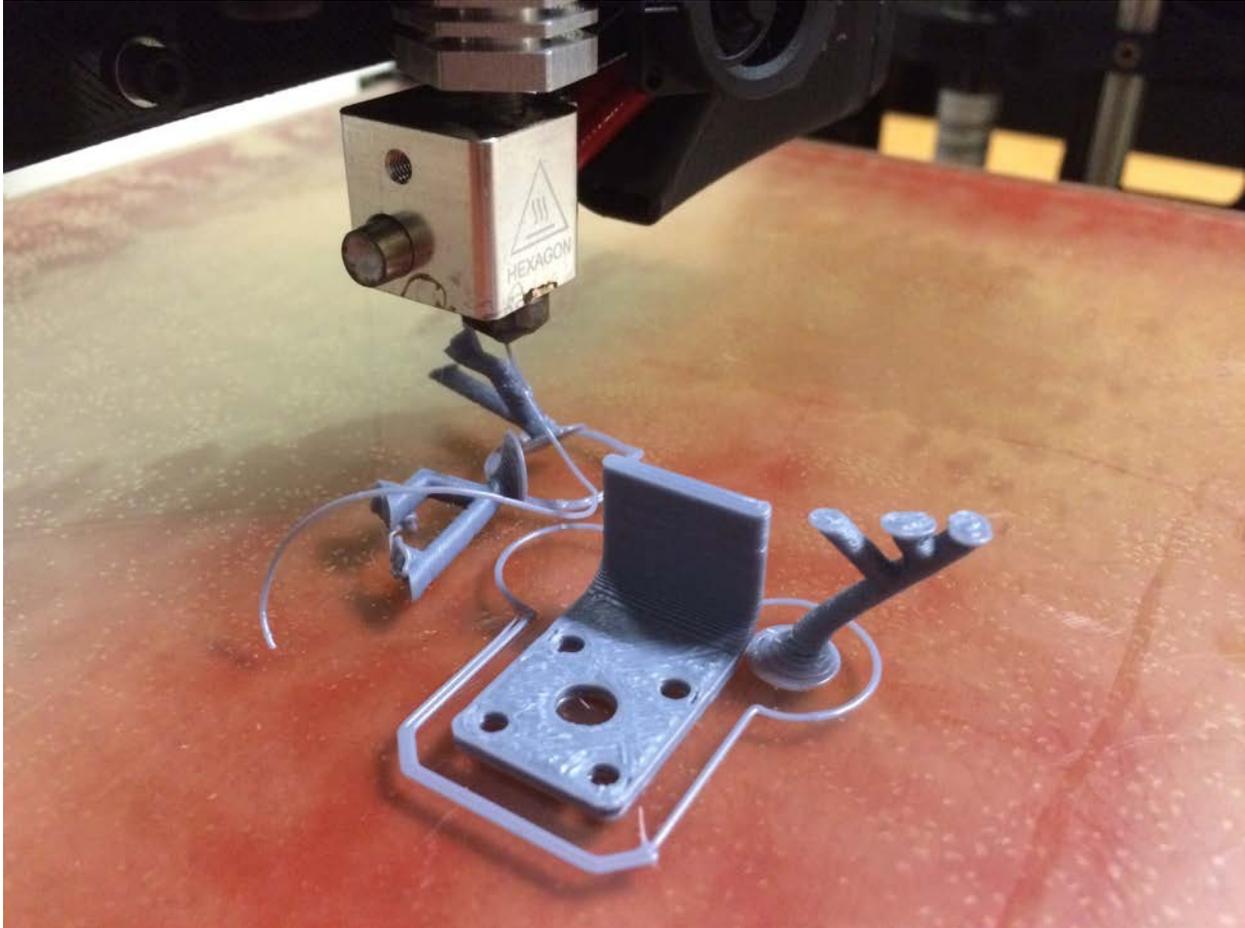
Figure 43: Autodesk Print Studio produces organic support material shapes, as shown in this print of the fire extinguisher bracket. Note that the print failed when one of the supports was knocked over.

- Most of the slicing engines accommodate support material using a single print-head system by generating a rectilinear support scaffolding structure with very limited contact points underneath any overhanging part features. Autodesk Print Studio produced a completely different type of support material, exhibiting a tree-like organic form with a main trunk and many branches at the top of the structure as shown in figure 43. The single print attempt of a file with this type of support failed when the printer head knocked over one of the tree-like structures.

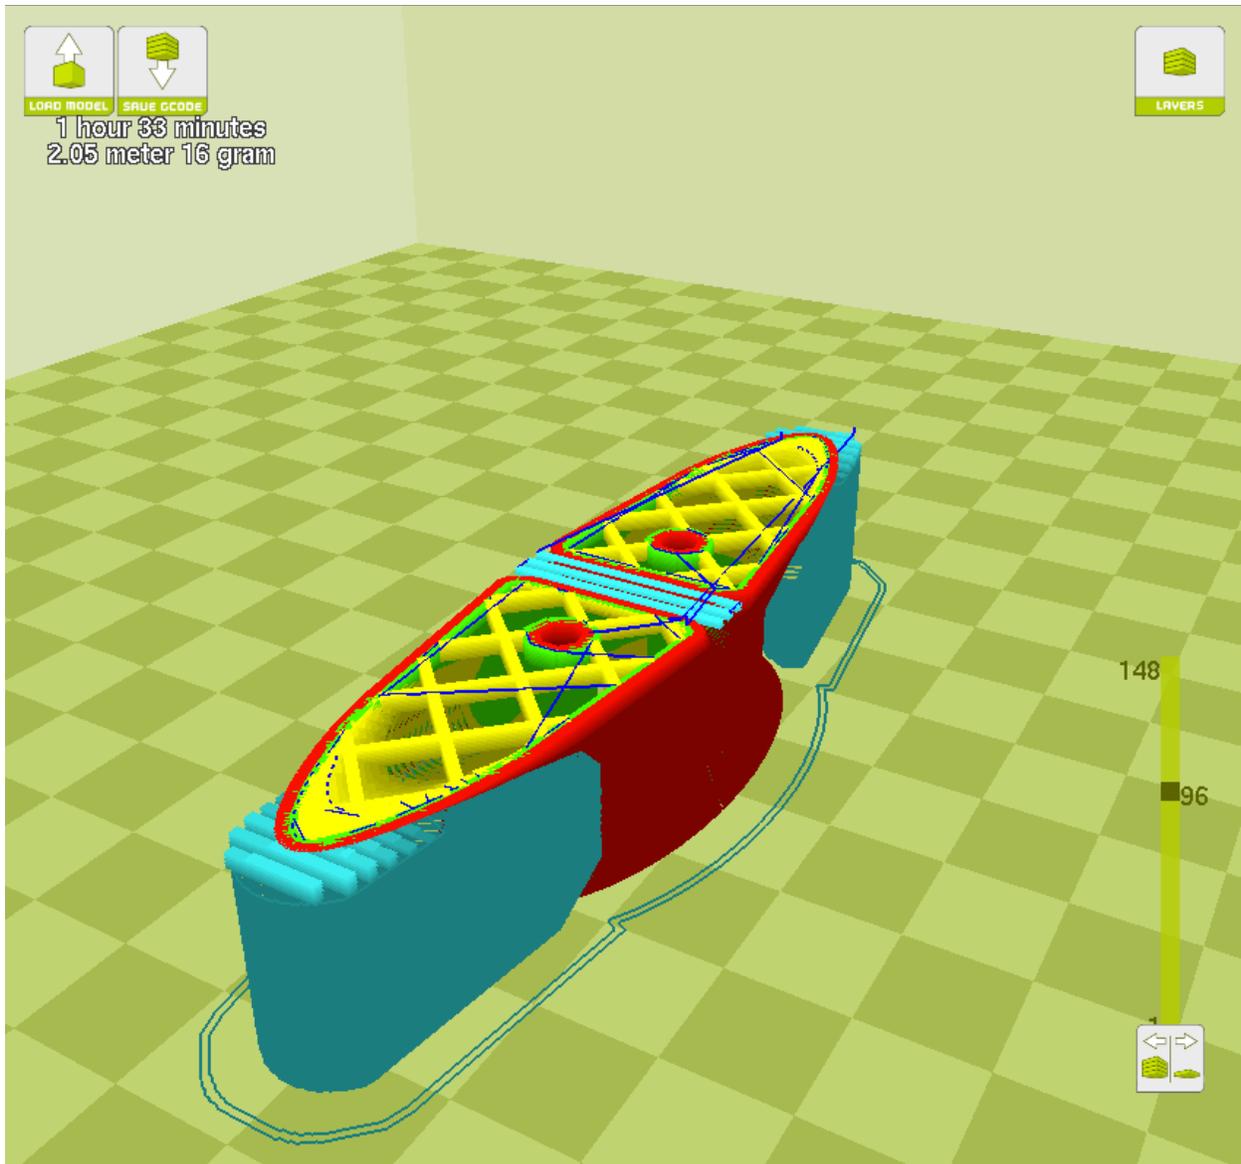
Figure 44: This Rope Cleat screenshot from Cura shows a square infill pattern and linear support material.

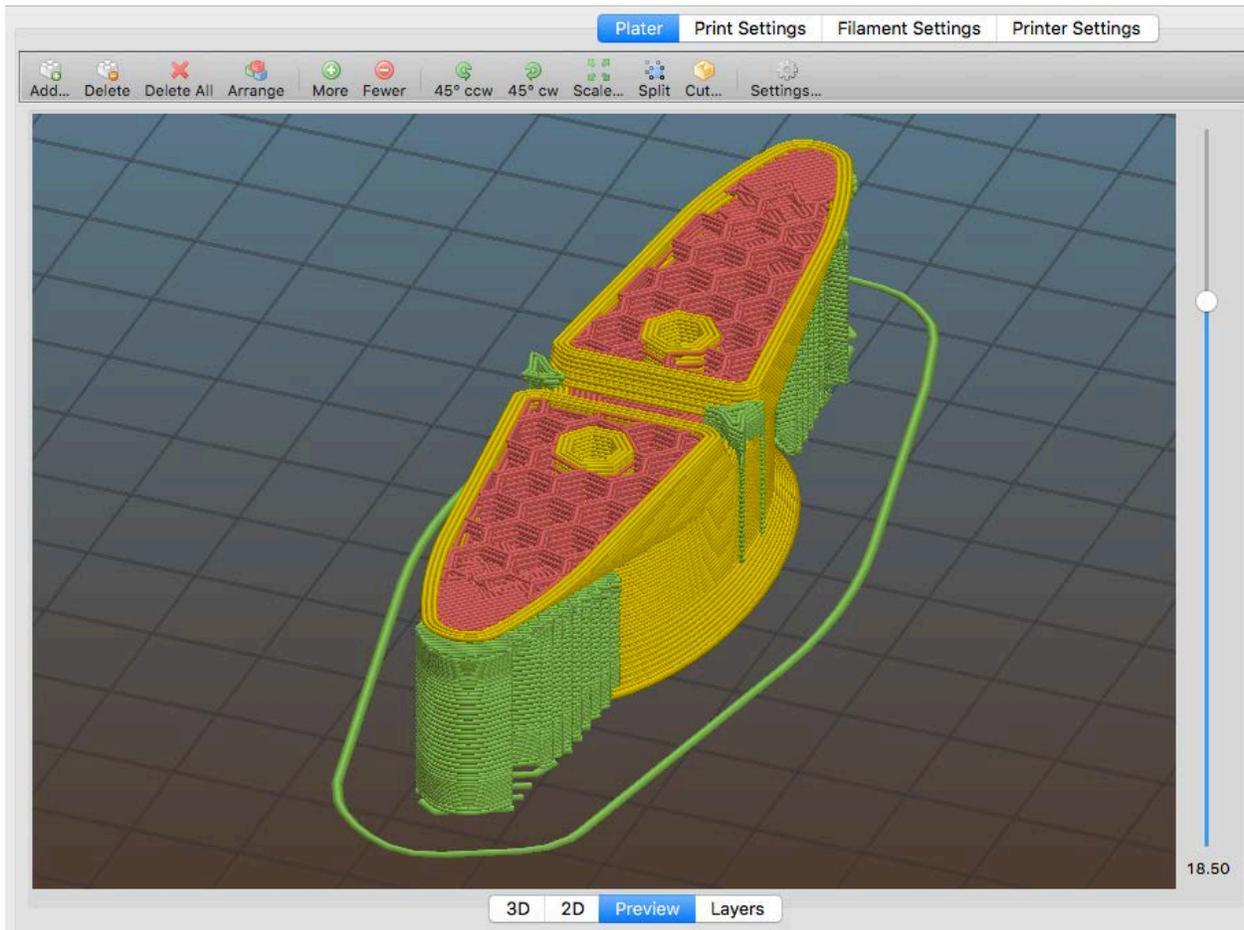
Figure 45: This Rope Cleat screenshot from Slic3r shows hexagonal infill pattern and linear support material.

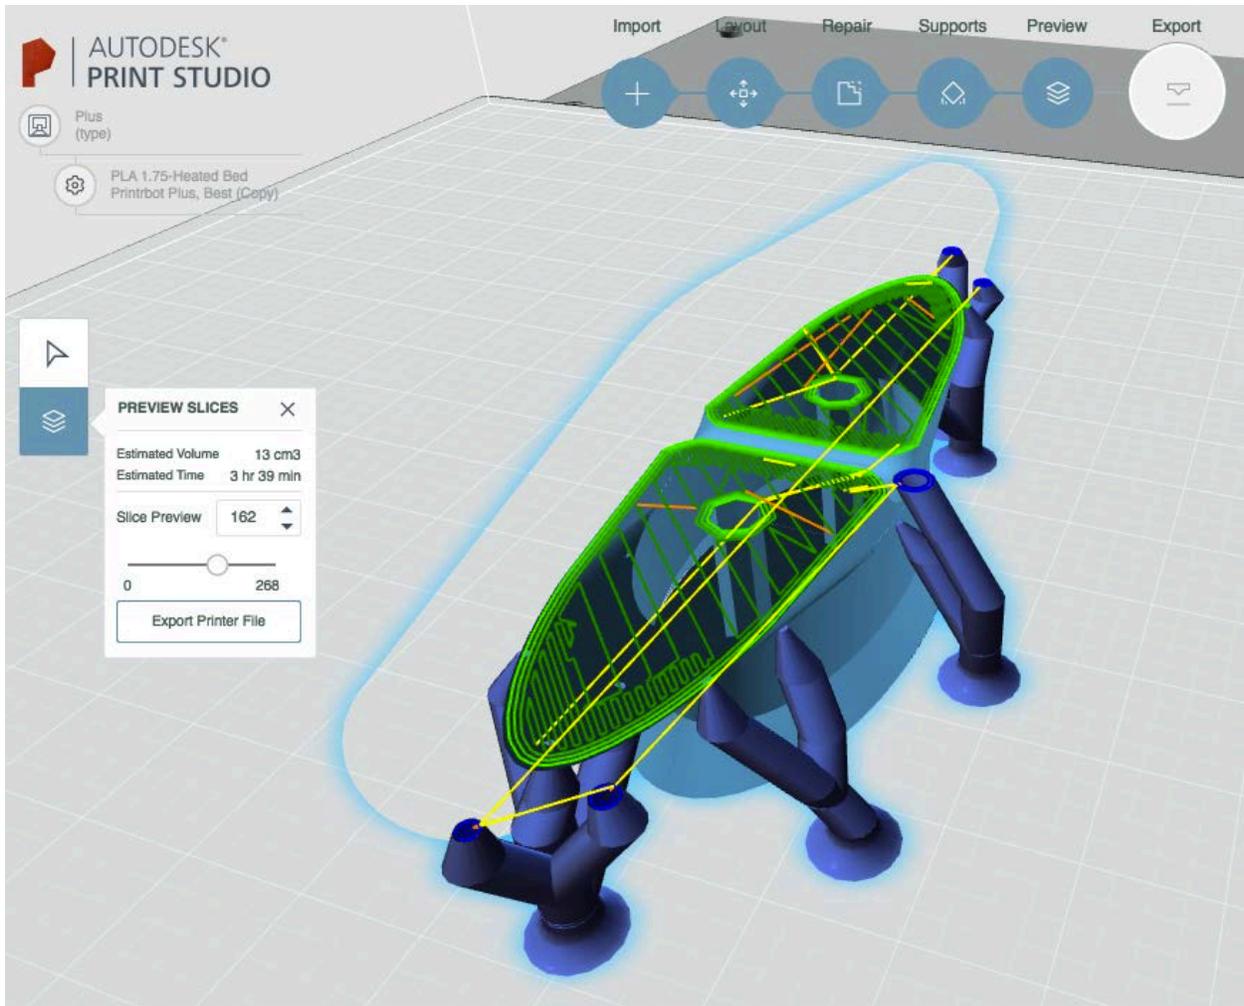
Figure 46: This Rope Cleat screenshot from Autodesk Print Studio shows alternating linear infill pattern and organic-type support material.

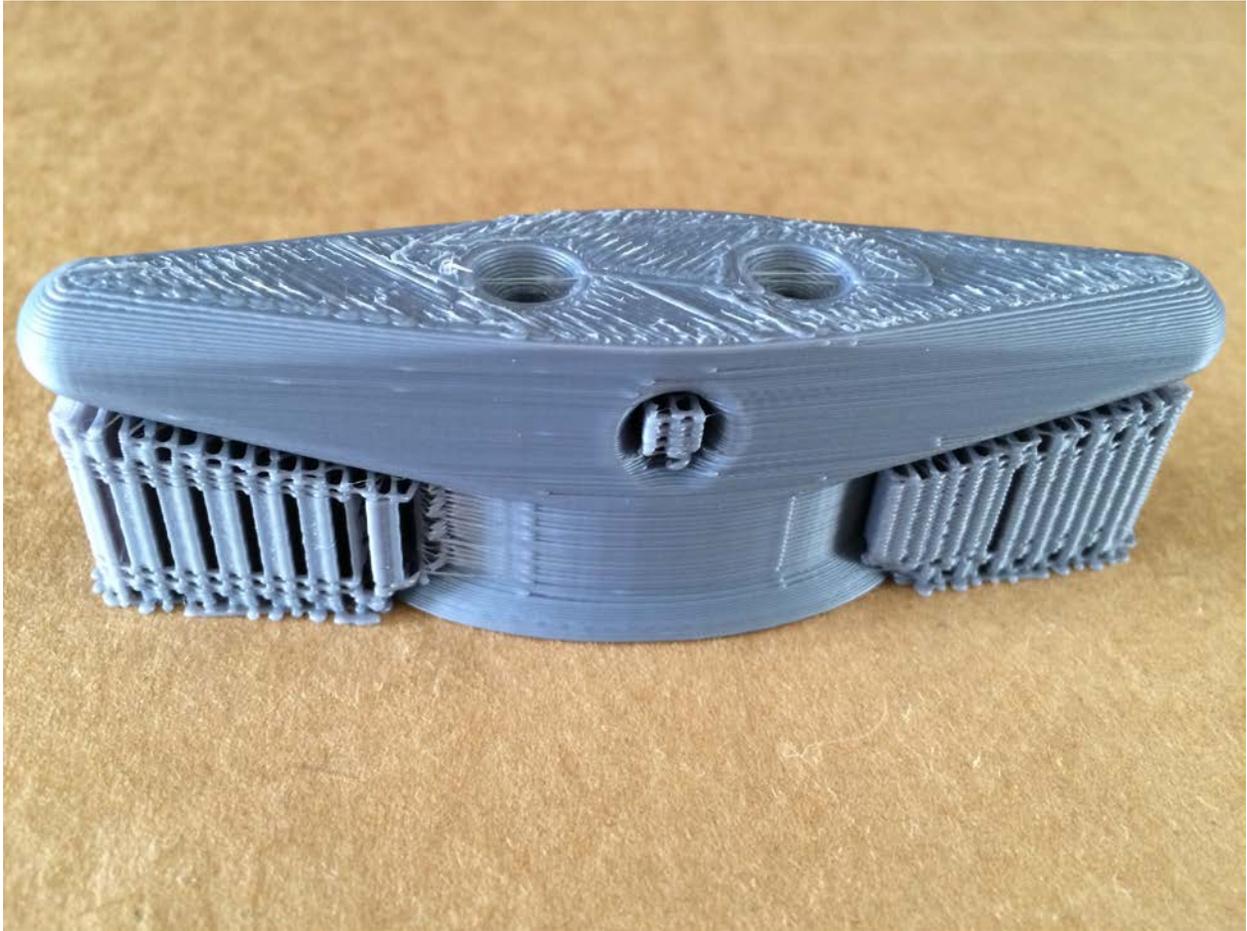
Figure 47: This print of the rope cleat shows the extent of support material generated by Cura to support the overhanging model areas.

- Each slicing engine provides different alternatives for infill geometry. All engines can generate rectilinear infill, however some can produce honeycomb, concentric, spiral, zig-zag, and other unique patterns. Cura is limited to a continuous rectilinear square infill pattern shown in figure 44. Slic3r has options to produce a wide variety of patterns listed above, and a honeycomb pattern is shown in figure 45. Autodesk Print Studio produces a linear array that alternates 90 degrees each layer as shown in figure 46, and employs organic forms for parts support structures. The resulting rope-cleat part produced from the Cura file can be seen in figure 47, and the de-burred part can be seen in figure 48.

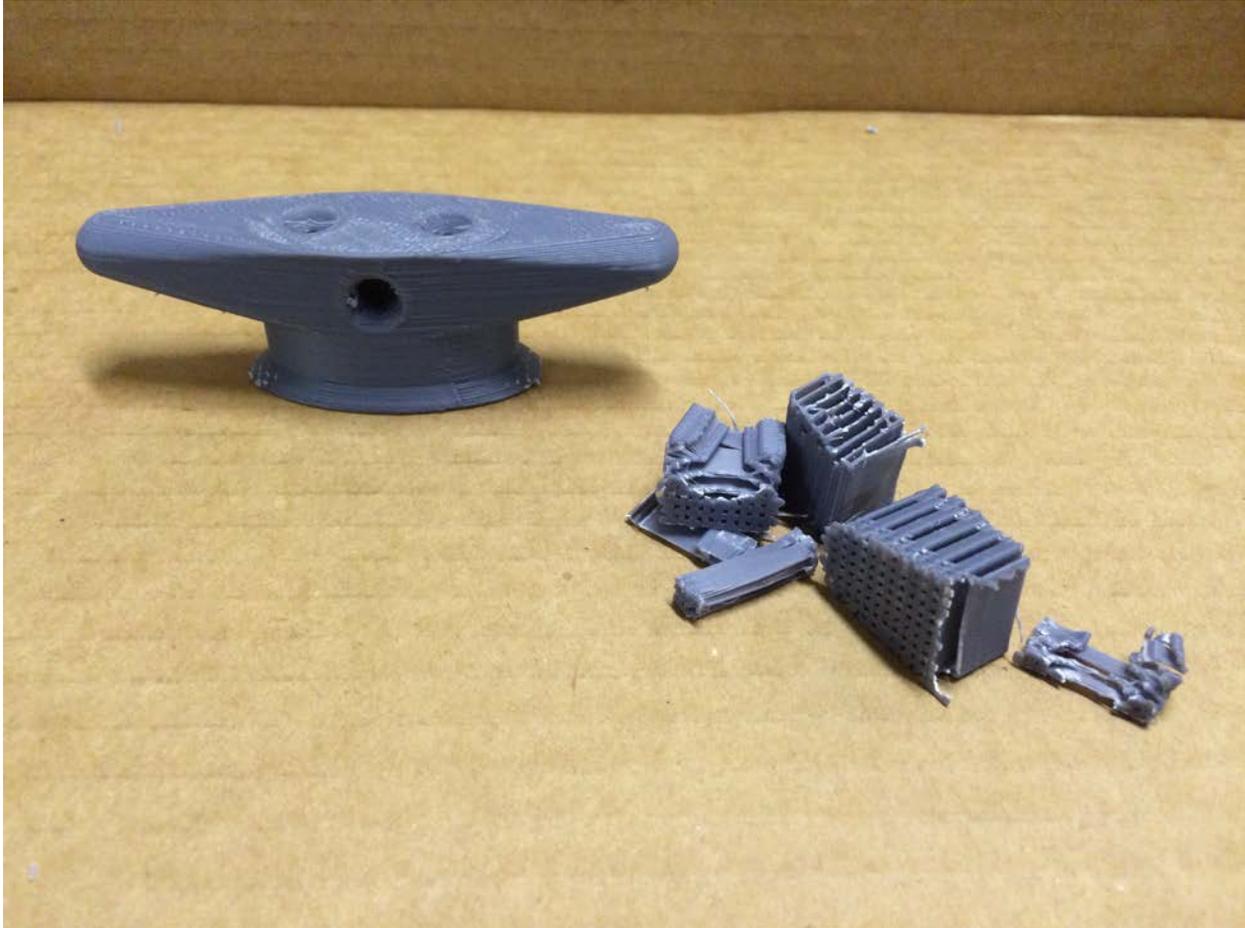
Figure 48: The support material is easy to strip from the actual part and does not significantly degrade part finish quality.

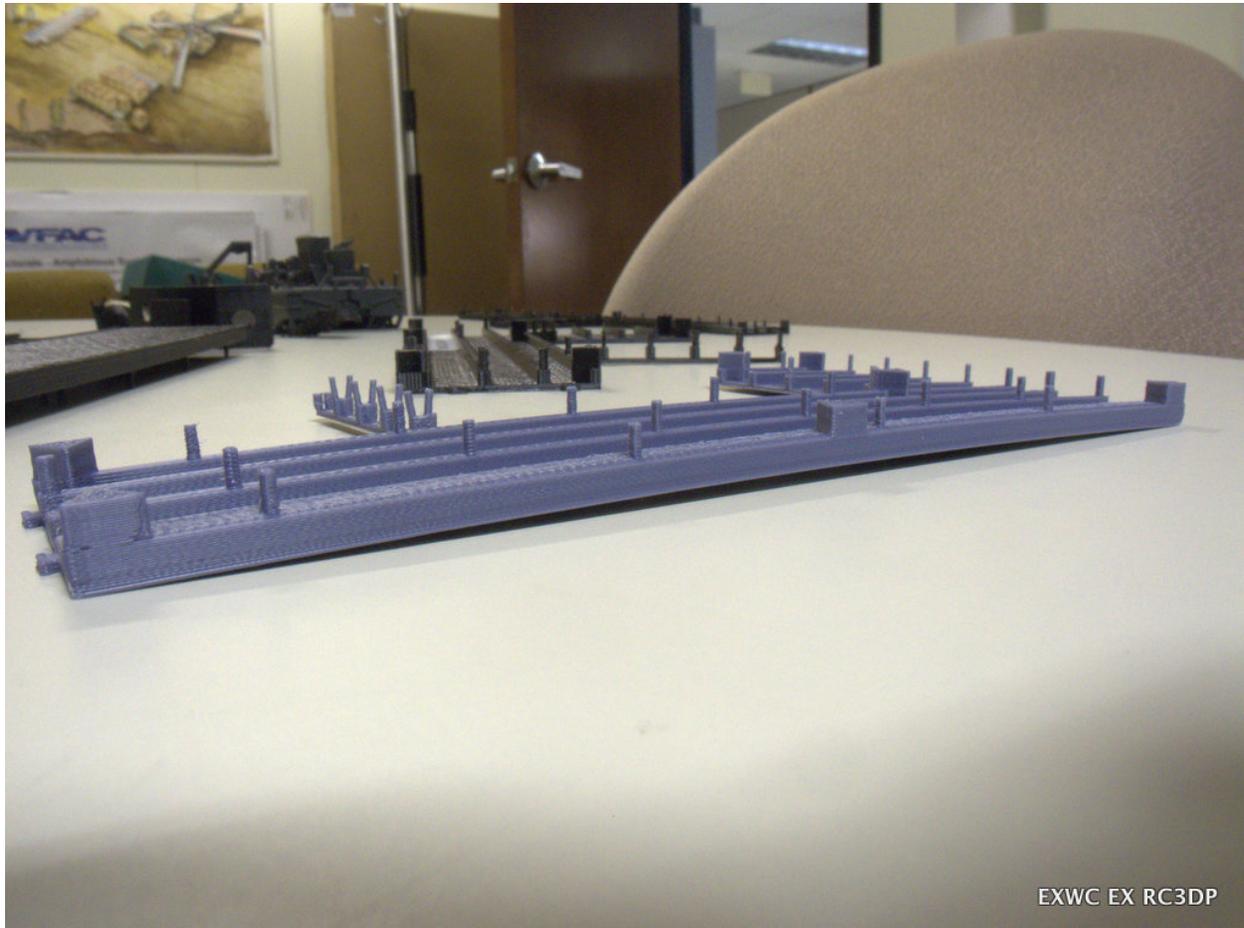
Figure 49: This HIPS print of the pier shows the warping caused by residual thermal stress.

As a result of the printer configuration, with a heated bed and open build volume, parts produced on the TAZ5 exhibited significant residual thermal stress, resulting in post-production warping as shown in figure 49. This warping was observed on all parts except those with very high section moduli. Fortunately, a post-treatment annealing process proved successful, wherein the warped components were flattened, buried in sand to control heat transfer, and baked in an oven. This was proven to correct the thermal distortion and was used effectively to

repair several pier and sub sections. This residual thermal stress is a non-issue with the Stratasys machine due to the enclosed build volume and the single-use non-heated build plate. A potential solution to the warping issue on the TAZ5 may be to build warp-prone parts on a complete raft of support material, isolating the base layer of the part from the heated build plate. Another option may be to numerically model the residual thermal stress and resulting warping, and modify the part design such that the part effectively warps itself flat (however, this would be very difficult given the linear nature of the FDM layer deposition process, and the uneven thermal profile through the z-height of the part).

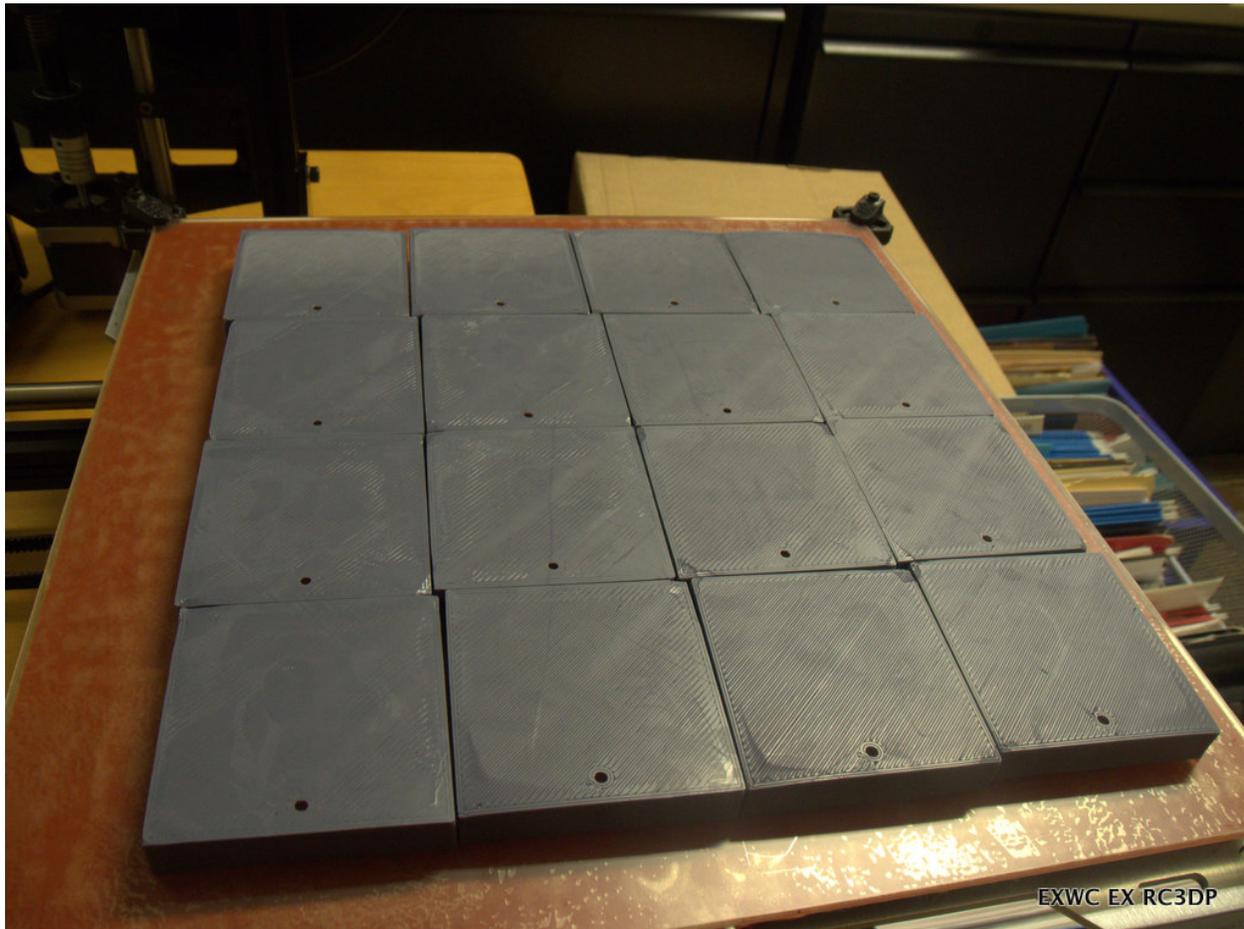
Figure 50: The bottom side of a batch print operation reveals multiple instances of bed adhesion failure in the corners, however this did not compromise the print.

resulting in unique part appearances. The overall shape of parts is identical for all intents and purposes, but it is clear that the start/stop “seam” is in a different place on each part resulting in a difference of appearance as shown in figure 51. Additionally, each part exhibited different bed adhesion issues and regions as shown in figure 50. Nearly all of the parts printed in the array showed some level of bed adhesion failure at the corners, but the extent and area on each part was slightly different. None of the bed adhesion issues resulted in print failure.

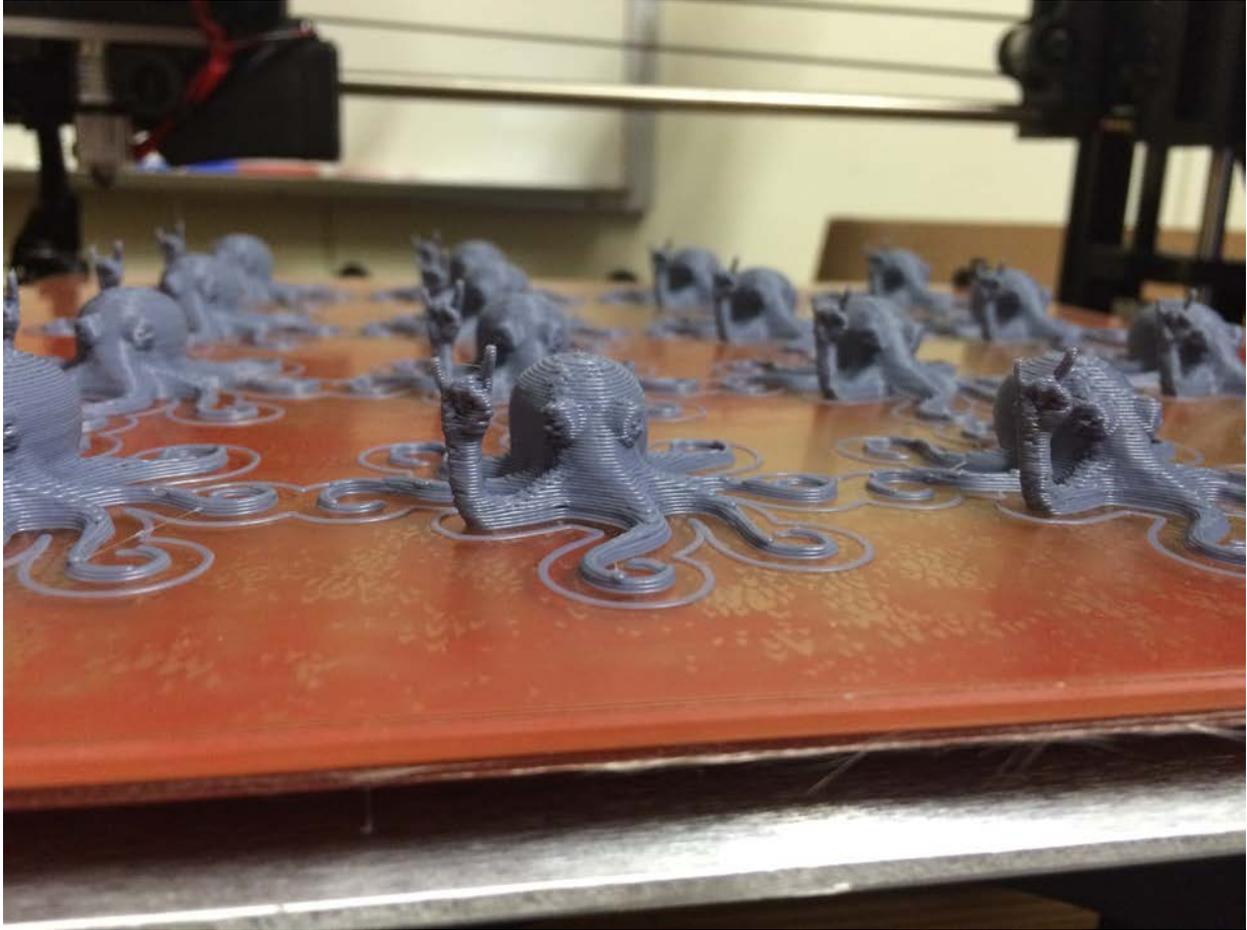
Figure 51: The batch print operation of the "Rocktopus" model revealed that each instance showed minor variation based on extrusion start/stop points.

Several multiple-print operations were executed (TAZ5-0018 INLS shadowboxes, and TAZ5-0031-0033 Rocktopus), and important phenomenon were observed with each. Though the arrayed models of the parts may be identical in software, each part produced by the printer is unique. This is a result of the automatic tool-path generation that the slicing engines produce. Each part on the build plate may have different start and stop coordinates for each layer,
